INSPECTION REPORT

For the Property at:
2222 SUNNYSLOPE RD
MEQUON, WI 53097

Prepared for: MR. & MRS. SMITH
Inspection Date: Thursday, July 7, 2023
Prepared by: Michael Schwitzer

1st Choice Inspection
1603 Rockridge Way
Waukesha, WI 53188
414-803-9678

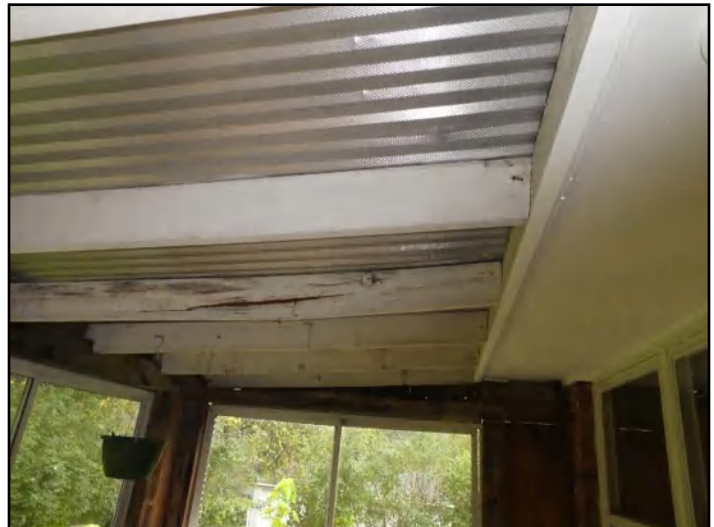
2. Leak

Condition: • [Leak](#)

The roof of the 3 season room leaks. This will need to be resealed.

Implication(s): Chance of water damage to structure, finishes and contents

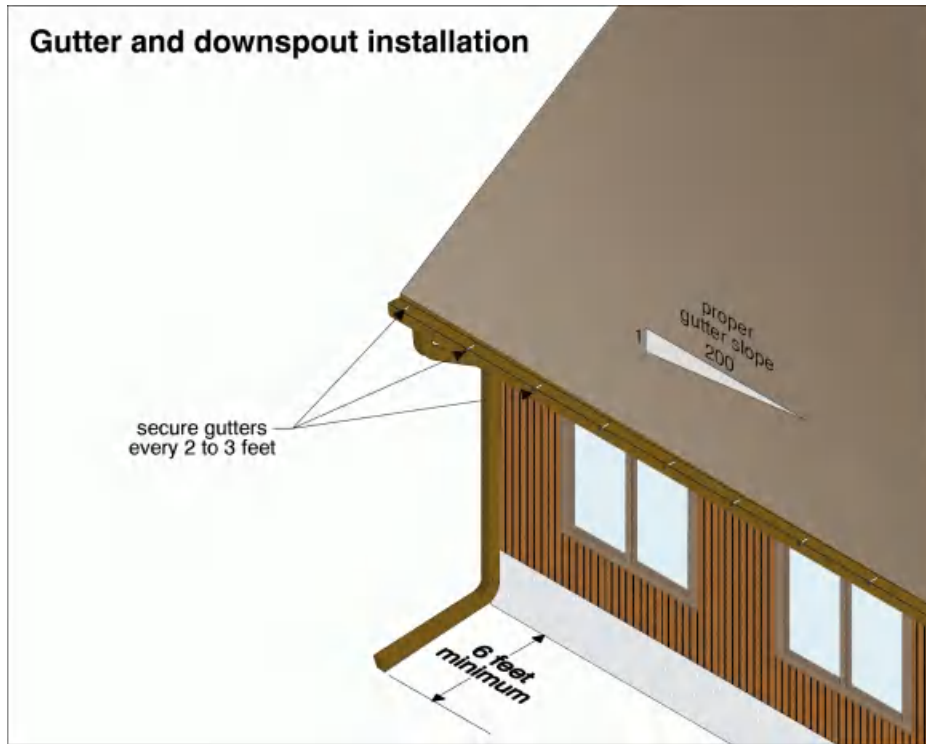
5. Missing gutters

Condition: • [Missing](#)

missing gutter on the dormer for the second floor room. They should be installed to prevent splash on wood siding. Help to prevent wood rot.

Implication(s): Chance of water damage to structure, finishes and contents

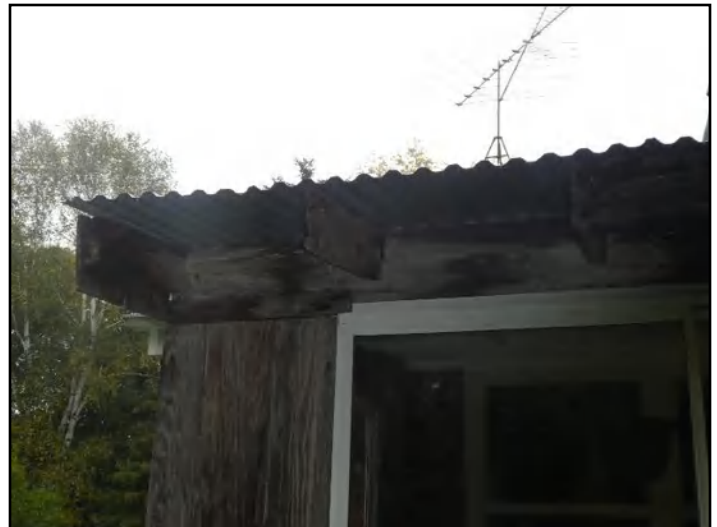
19. Wood rot

Condition: • Wood rot

Wood rot visible on 3 season room.

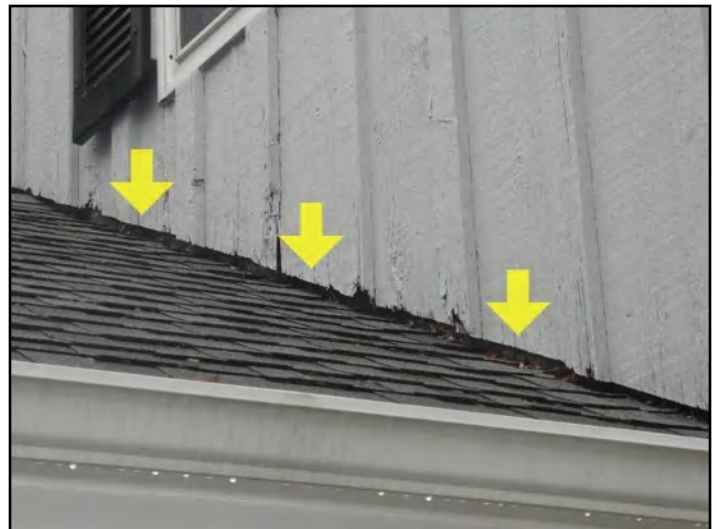
23. High moisture in siding

Condition: • The bottom few inches of the wood siding on the second story is rotting due to age and lack of maintenance.

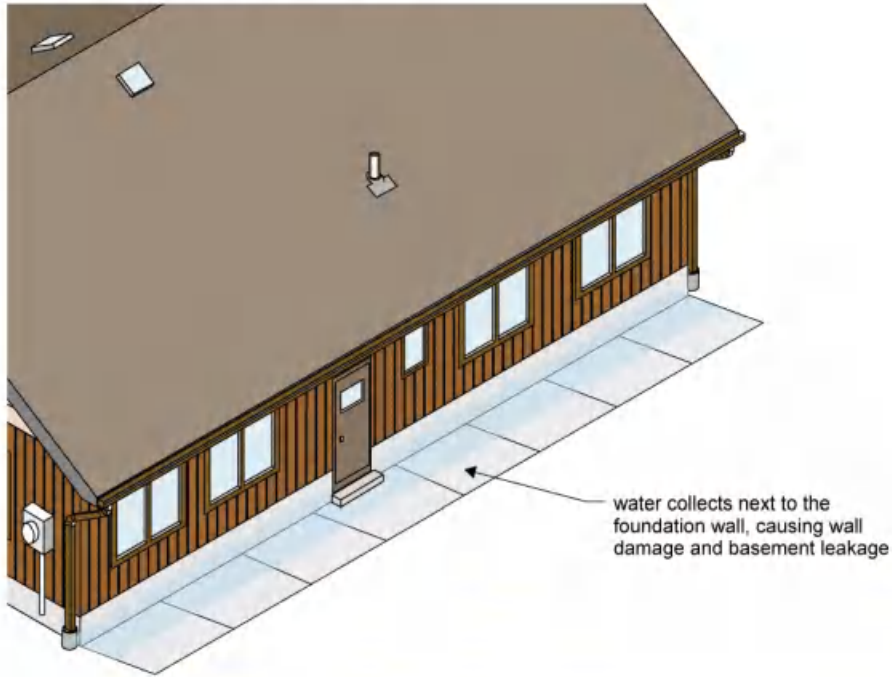
39. Improper slope or drainage

Condition: • [Improper slope or drainage](#)

The walkway from the driveway to the front door has dropped, sagged and improperly sloped. This will need to be addressed as additional water is penetrating the foundation and is visible on the interior of the home.

Implication(s): Chance of water damage to structure, finishes and contents

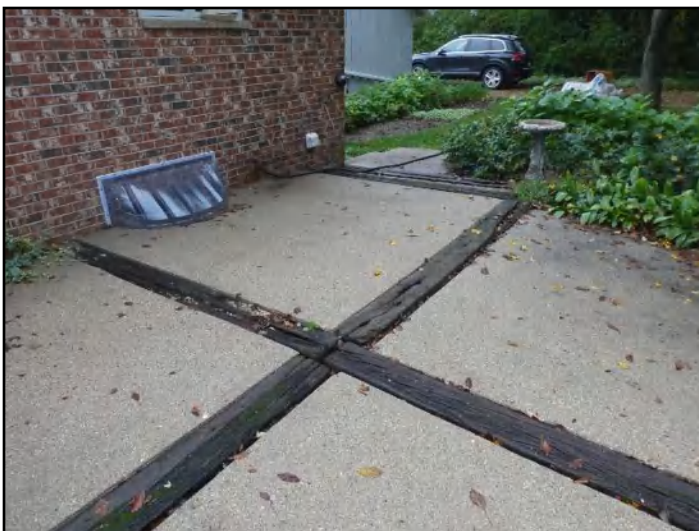
46. *Improper slope or drainage*

Condition: • Improper slope or drainage

The concrete patio in the back slopes towards the foundation as well as the steps and walk that comes from the garage. This will need to be mud-jacked or removed and replaced.

Implication(s): Chance of water damage to structure, finishes and contents

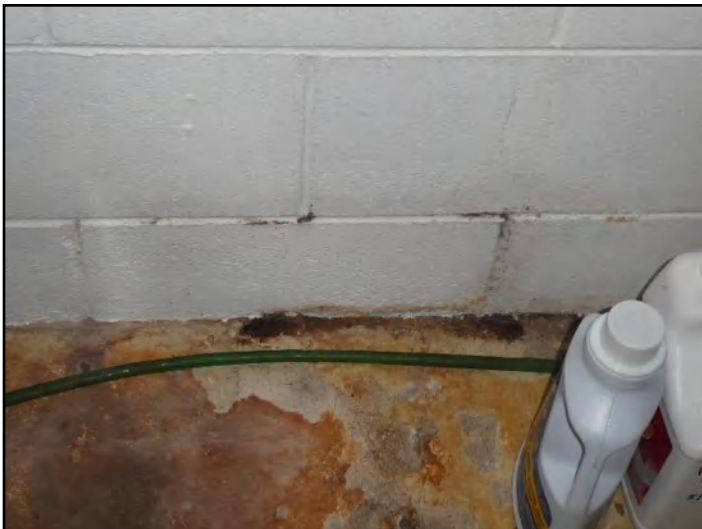
51. moisture on foundation wall

Condition: • Visible water on foundation wall.

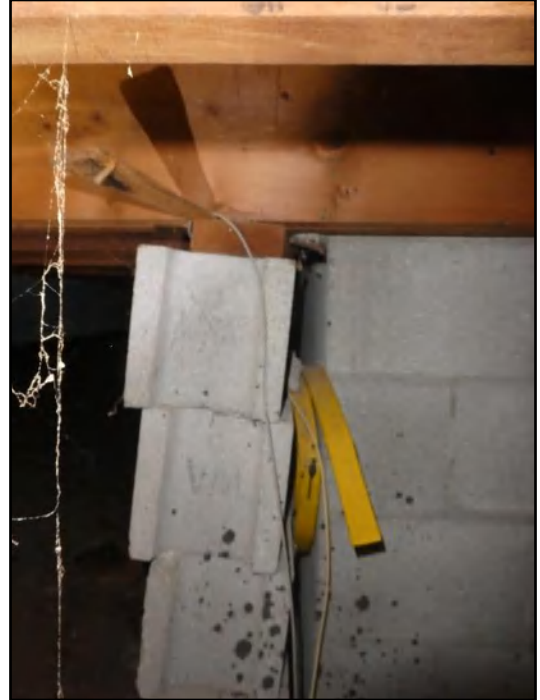
55. Improper support

Condition: • Improper support

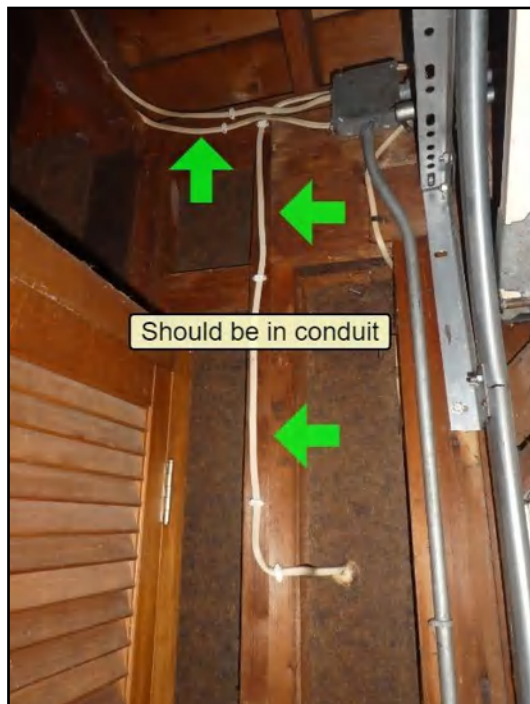
58. Unprofessional work. Consult licensed...

Condition: • Unprofessional work. Consult licensed electrician to correct issues.

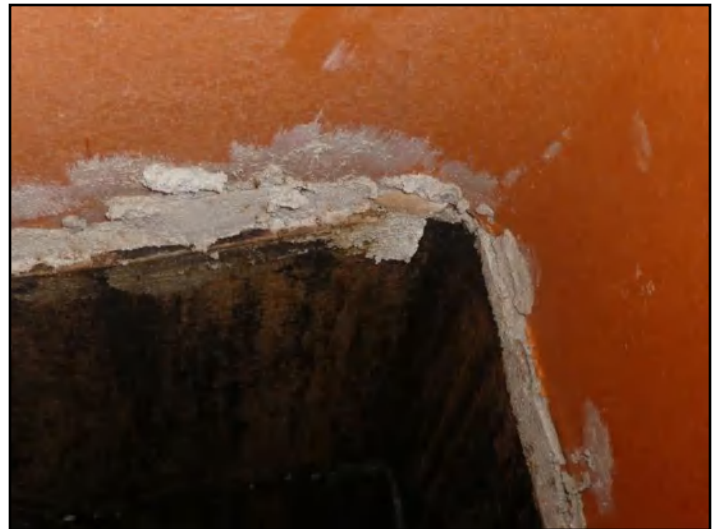
61. Poor flue repair

Condition: • Being rebuilt. The visible flue needs attention. Also the clay liner below the new one is cracked and should be replaced. A flue liner is also needed for the water heater and will need to be installed.

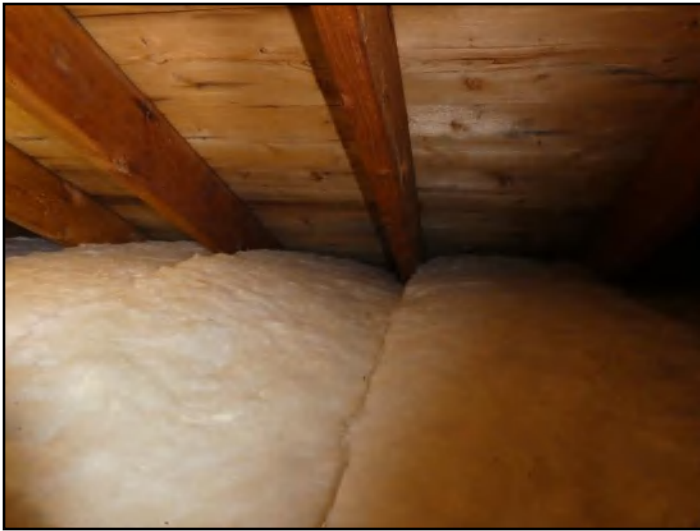
66. Missing baffles

Condition: • Missing baffles

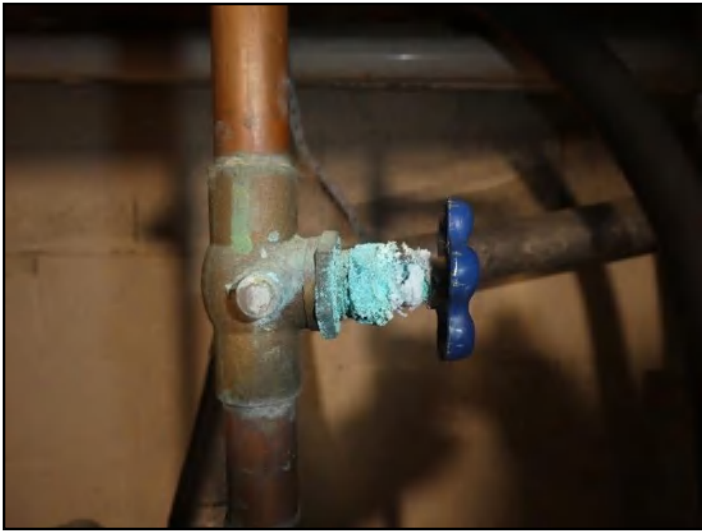
69. Leaking valve

Condition: • Corrosion at valve. Leaking and should be replaced.

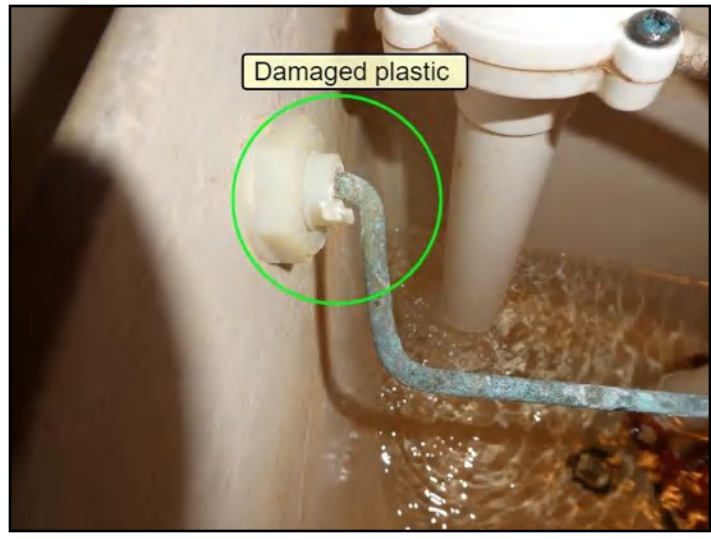
80. Handle damage

Condition: • Handle damage

The toilet handle in the 1/2 bath on first floor needs to be replaced as it is damaged and does not properly flush.

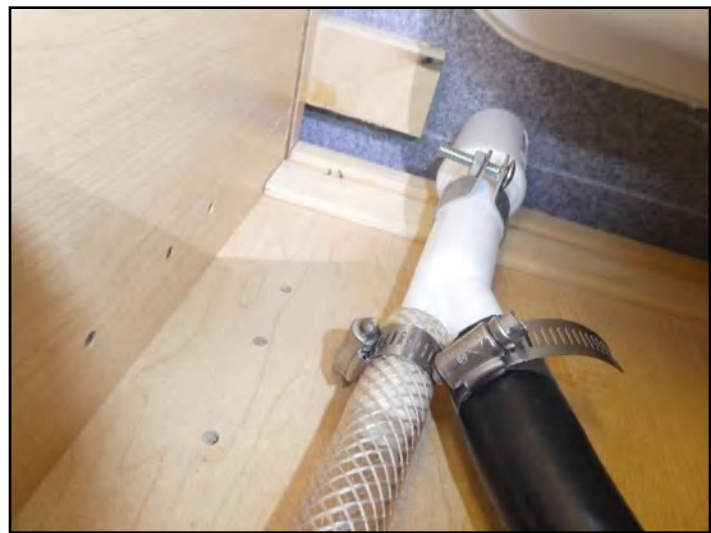
81. Air gap issues

Condition: • Air gap issues

The air gap for the dish washer is not properly installed. Correct by licensed plumber.

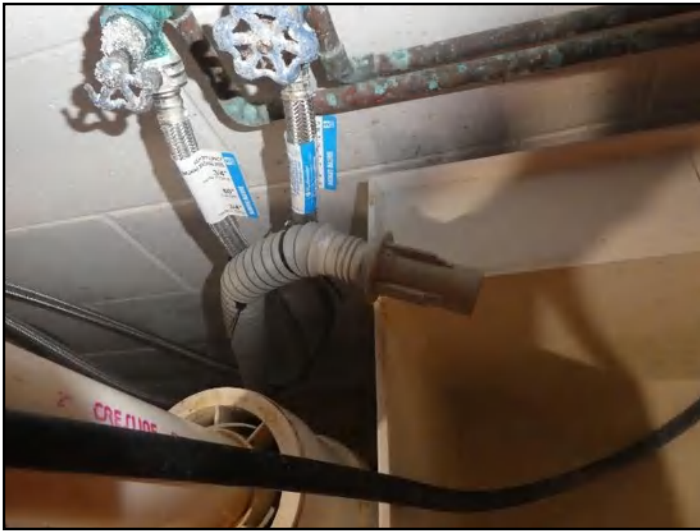
82. Missing stand pipe

Condition: • Missing stand pipe

Laundry tub upgrade required a wash machine stand pipe be installed. This is missing and washer should not discharge in tub.

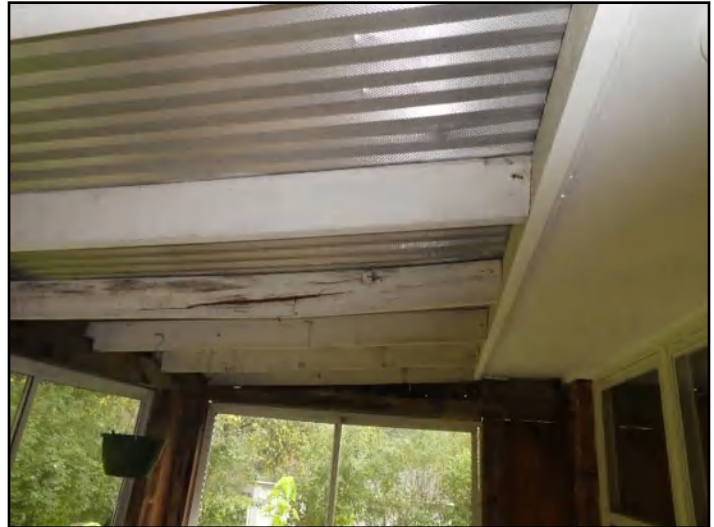
85. Leak

1. Condition: • [Leak](#)

The roof of the 3 season room leaks. This will need to be resealed.

Implication(s): Chance of water damage to structure, finishes and contents

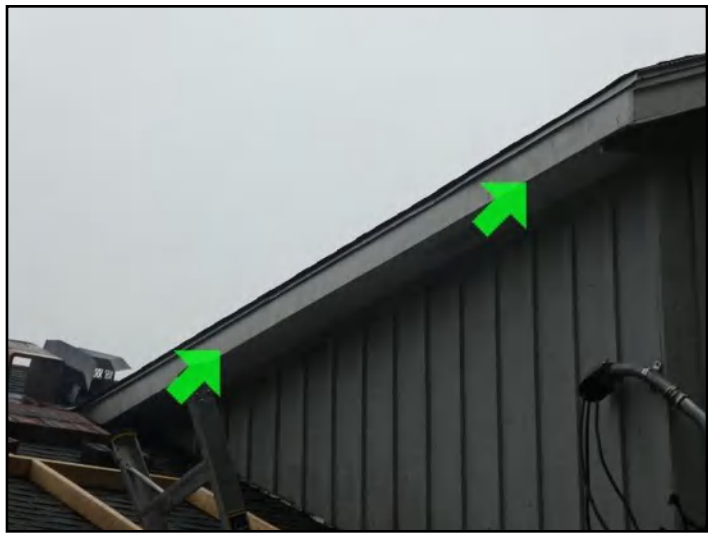
88. Missing gutters

5. Condition: • [Missing](#)

missing gutter on the dormer for the second floor room. They should be installed to prevent splash on wood siding. Help to prevent wood rot.

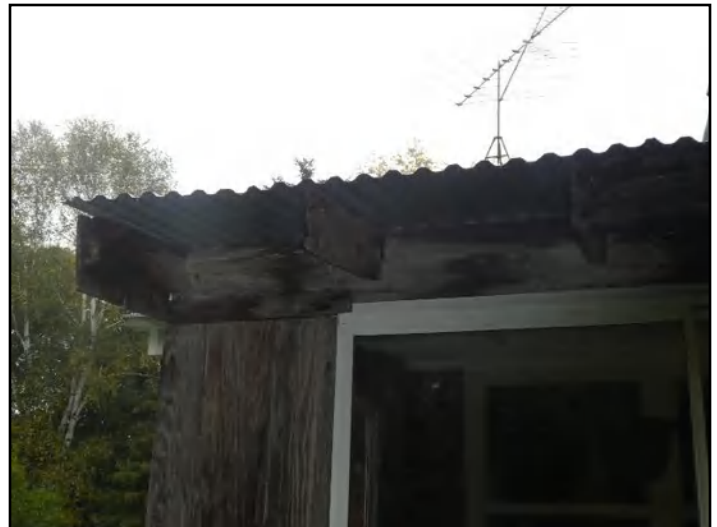
99. Wood rot

12. Condition: • Wood rot

Wood rot visible on 3 season room.

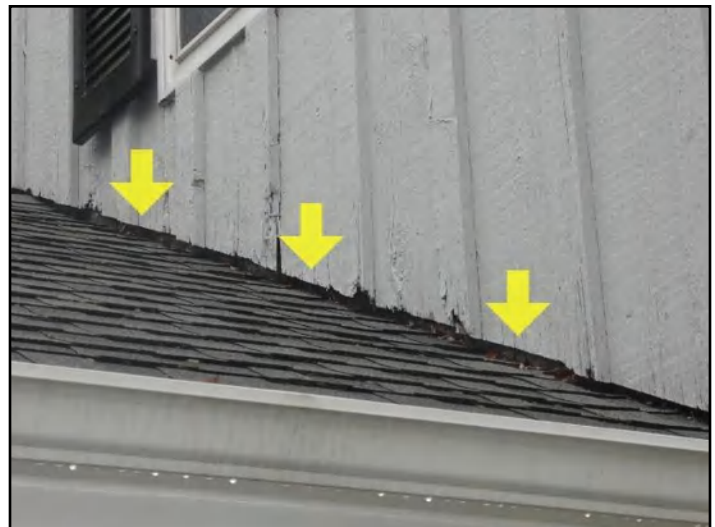
106. High moisture in siding

16. Condition: • The bottom few inches of the wood siding on the second story is rotting due to age and lack of maintenance.

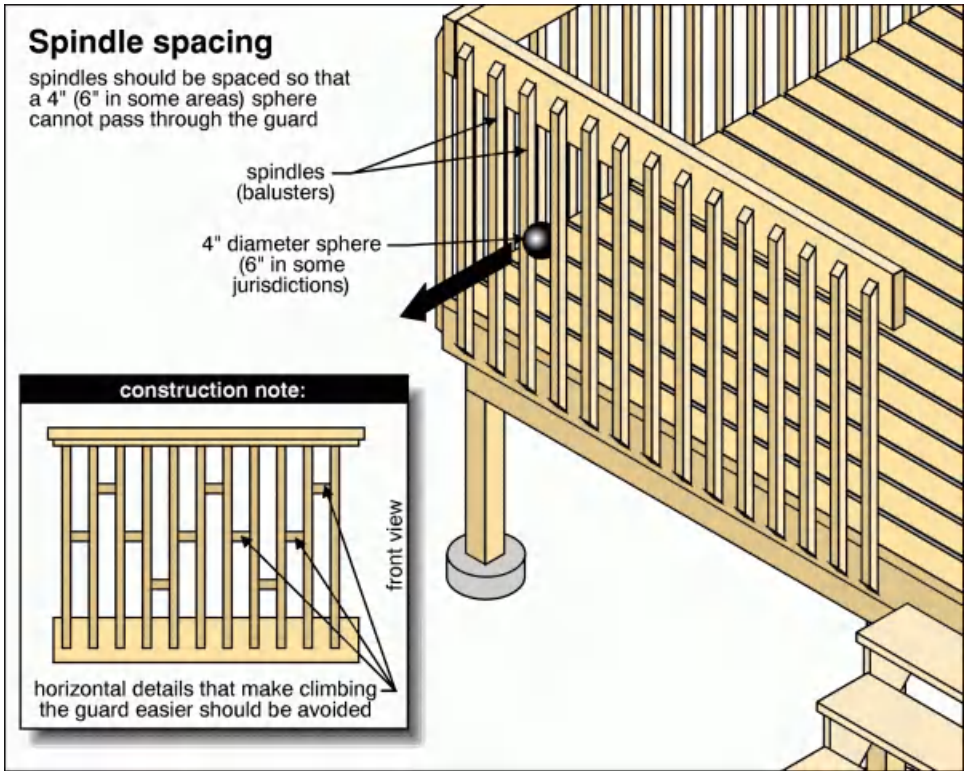
113. Spindles (balusters) too far apart

20. Condition: • [Spindles \(balusters\) too far apart](#)

Implication(s): Fall hazard

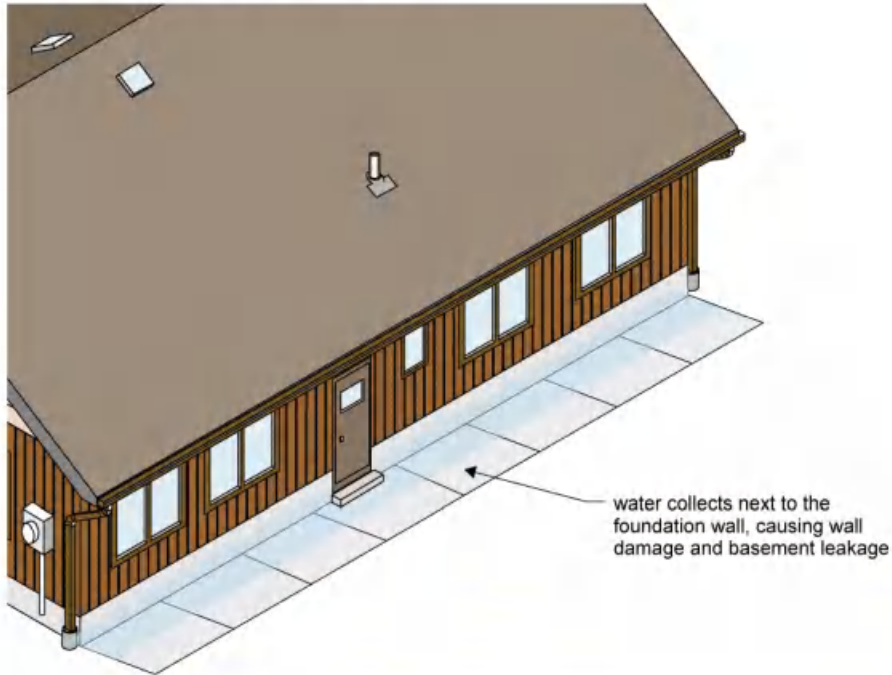
124. Improper slope or drainage

23. Condition: • [Improper slope or drainage](#)

The walkway from the driveway to the front door has dropped, sagged and improperly sloped. This will need to be addressed as additional water is penetrating the foundation and is visible on the interior of the home.

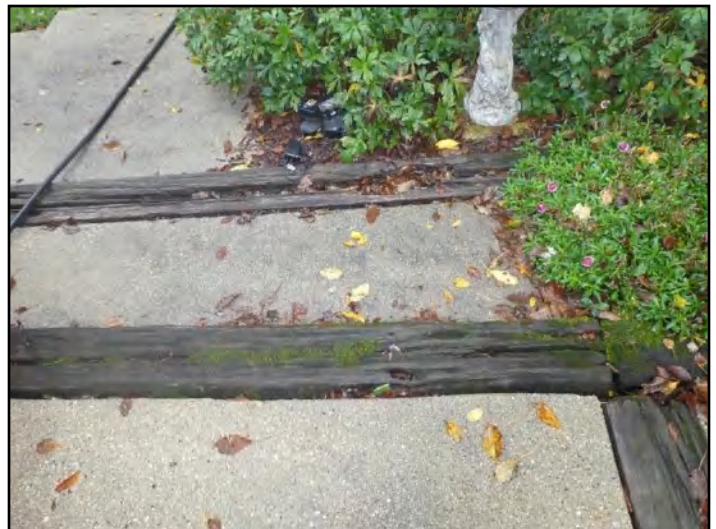
132. Improper slope or drainage

24. Condition: • Improper slope or drainage

The concrete patio in the back slopes towards the foundation as well as the steps and walk that comes from the garage. This will need to be mud-jacked or removed and replaced.

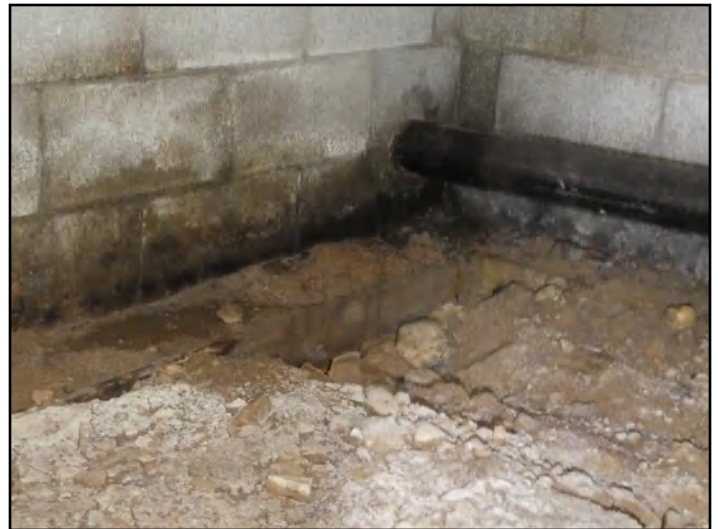
138.

30. Condition: • Visible water on foundation wall.

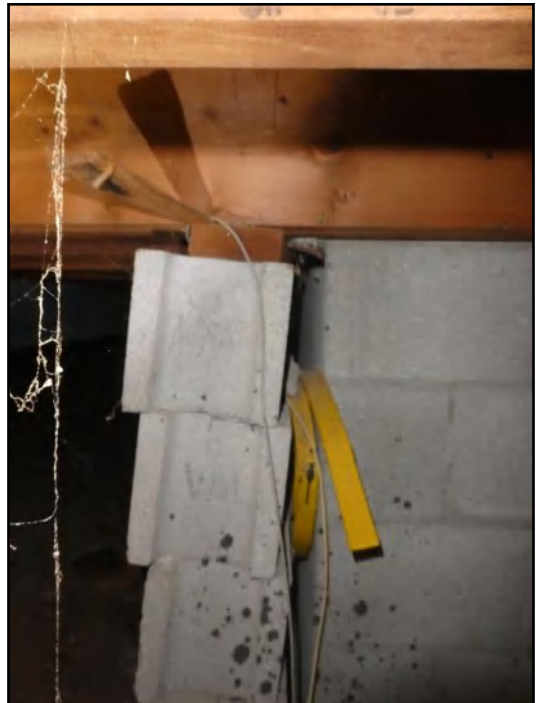
140. *Improper support*

32. Condition: • Improper support

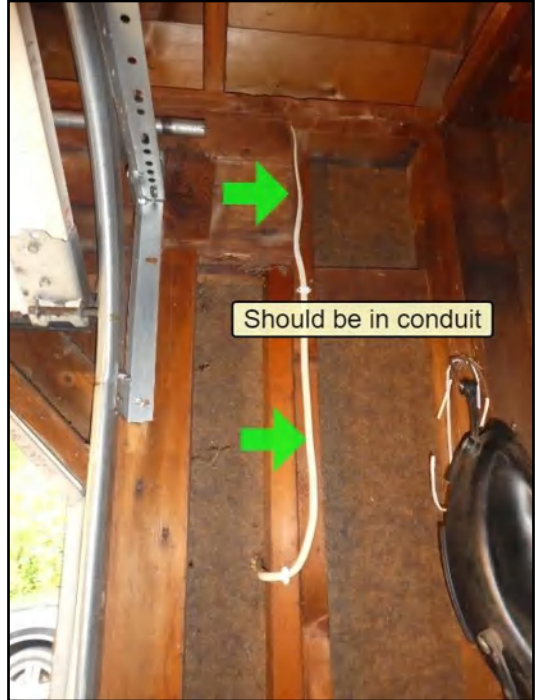
143. Unprofessional work. Consult licensed...

34. Condition: • Unprofessional work. Consult licensed electrician to correct issues.

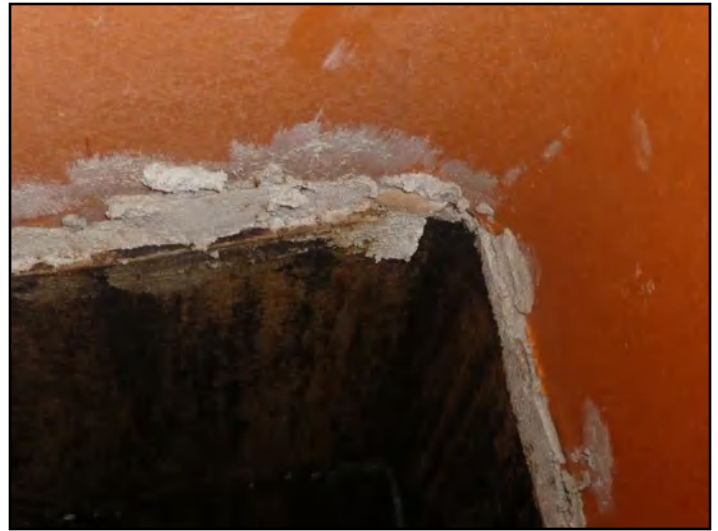
150. Poor flue repair

39. Condition: • Being rebuilt. The visible flue needs attention. Also the clay liner below the new one is cracked and should be replaced. A flue liner is also needed for the water heater and will need to be installed.

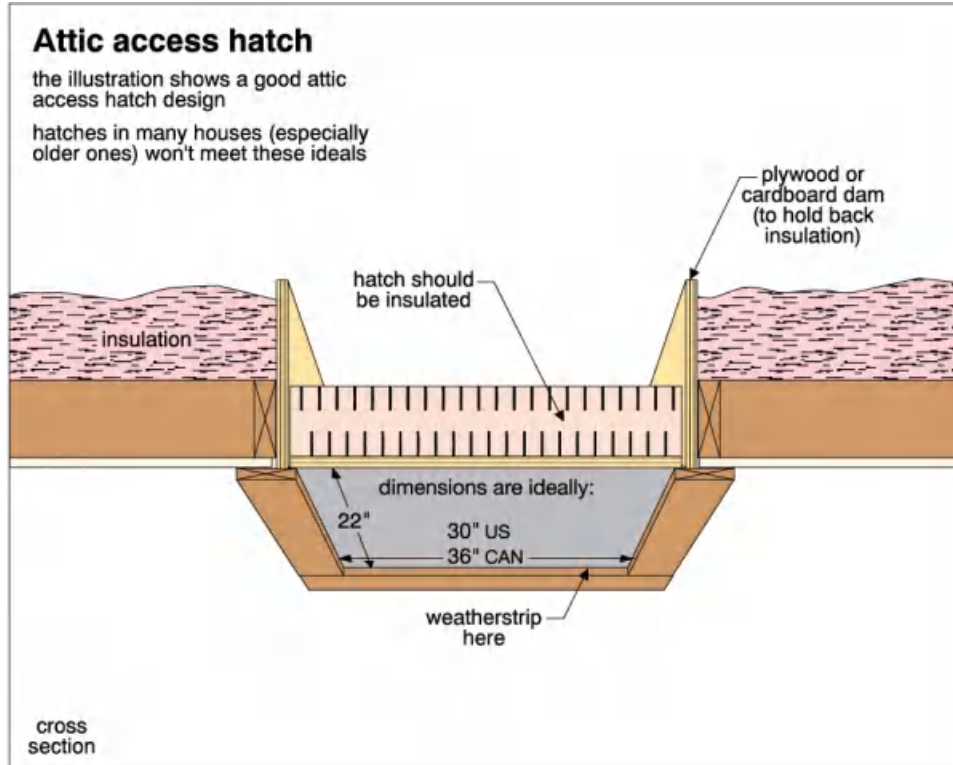
163. Not weatherstripped

41. Condition: • [Not weatherstripped](#)

Implication(s): Chance of condensation damage to finishes and/or structure | Increased heating and cooling costs

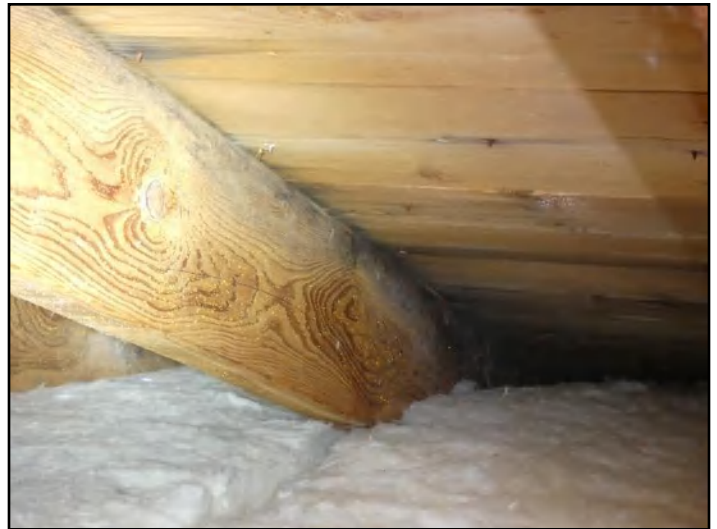
165. Missing baffles

42. Condition: • Missing baffles

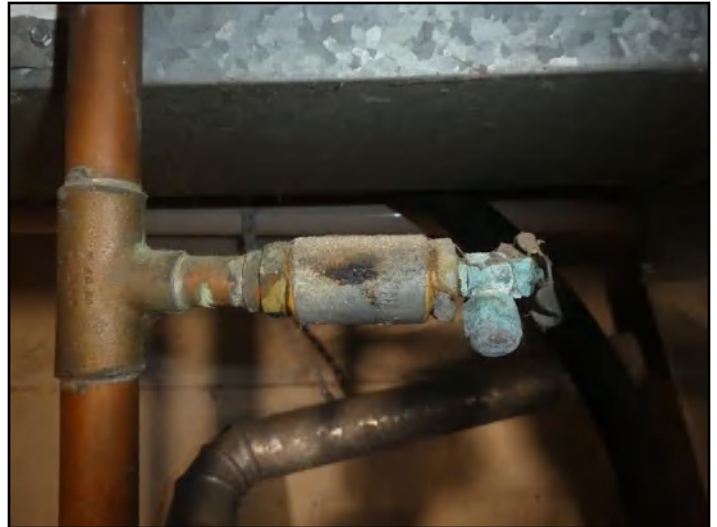
169. Leaking valve

44. Condition: • Corrosion at valve. Leaking and should be replaced.

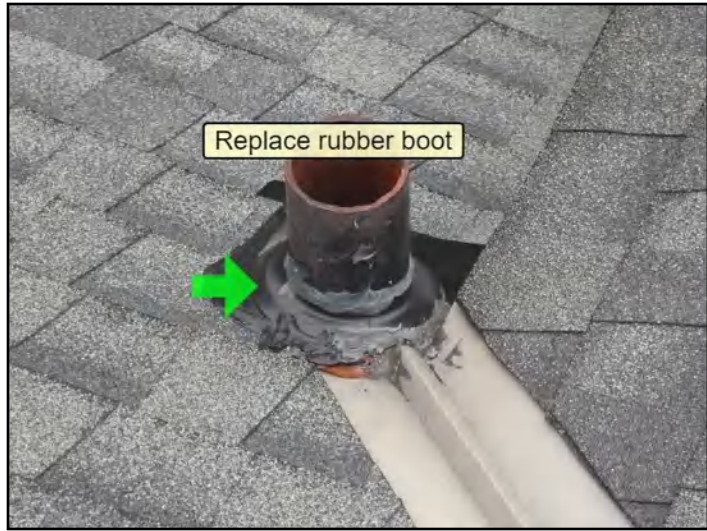
177. Vent stack

47. **Condition:** • Poor location for vent stack. Should replaced rubber boot as the repairs to rubber gasket are excessive.

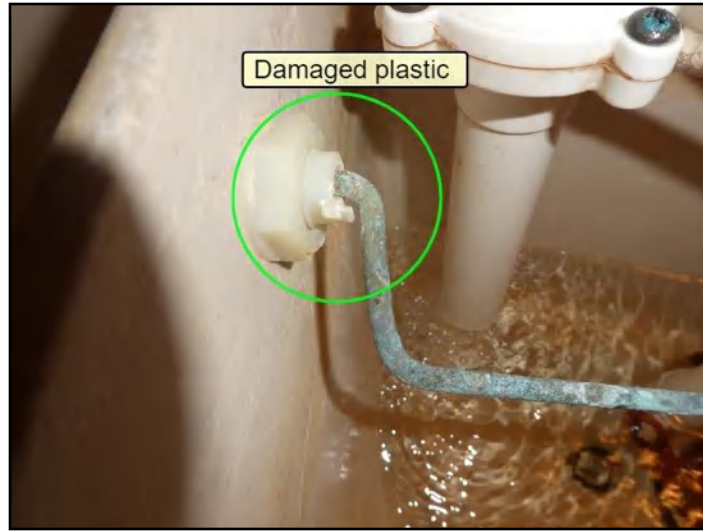
179. Handle damage

The toilet handle in the 1/2 bath on first floor needs to be replaced as it is damaged and does not properly flush.
