INSPECTION REPORT

For the Property at:
2222 SUNNYSLOPE RD
MEQUON, WI 53097

Prepared for: MR. & MRS. SMITH
Inspection Date: Thursday, July 7, 2023
Prepared by: Michael Schwitzer

1st Choice Inspection
1603 Rockridge Way
Waukesha, WI 53188
414-803-9678

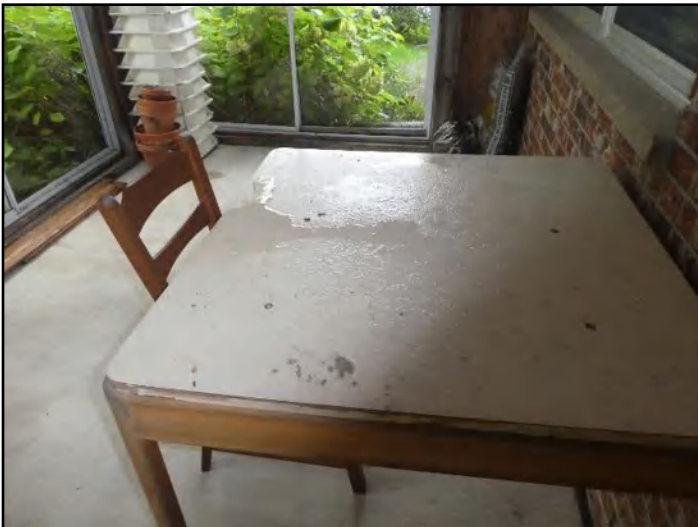
1. Leak

Condition: • [Leak](#)

The roof of the 3 season room leaks. This will need to be resealed.

Implication(s): Chance of water damage to structure, finishes and contents

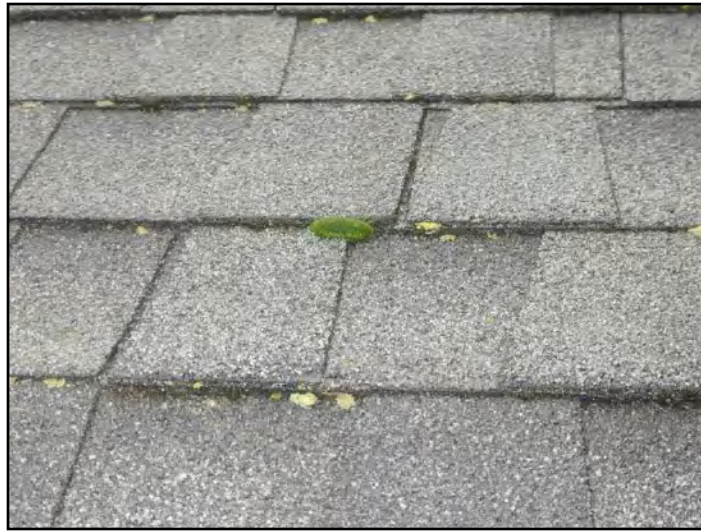
3. Moss, mildew, etc.

Condition: • Moss visible on shingles

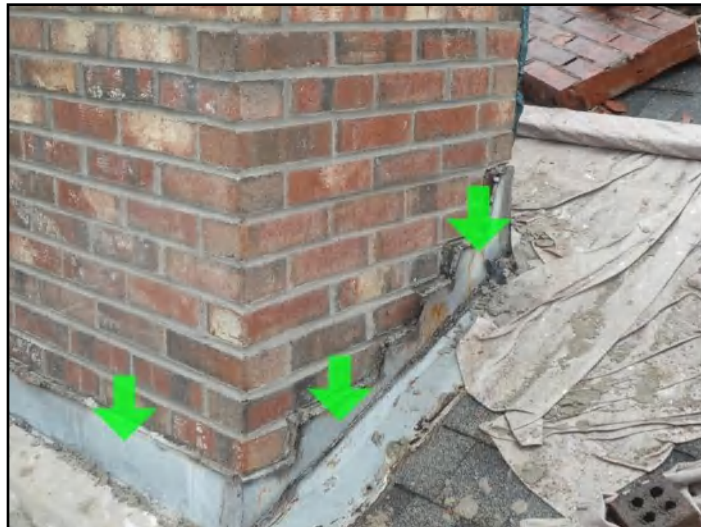
4. Old flashing

Condition: • Chimney being rebuilt. New flashed should be installed. Remove old flashing.

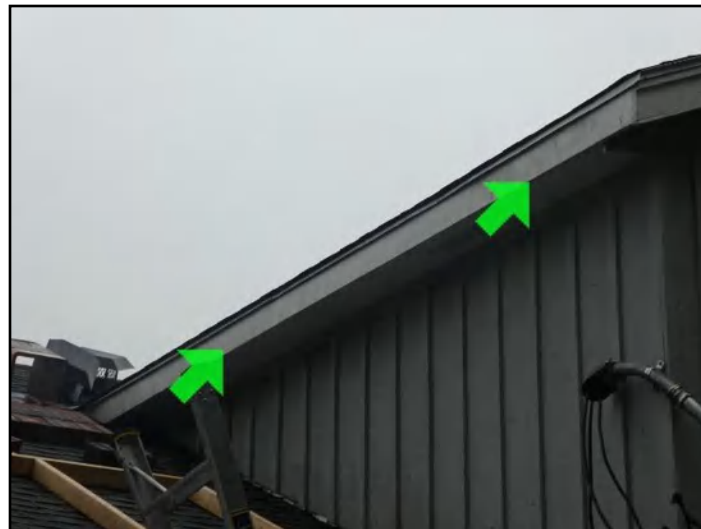
5. Missing gutters

Condition: • [Missing](#)

missing gutter on the dormer for the second floor room. They should be installed to prevent splash on wood siding. Help to prevent wood rot.

Implication(s): Chance of water damage to structure, finishes and contents

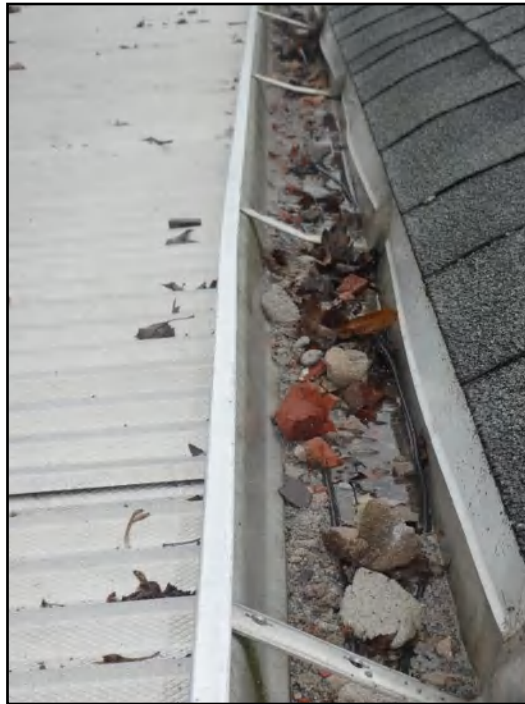
6. Dirty/debris

Condition: • Dirty/debris

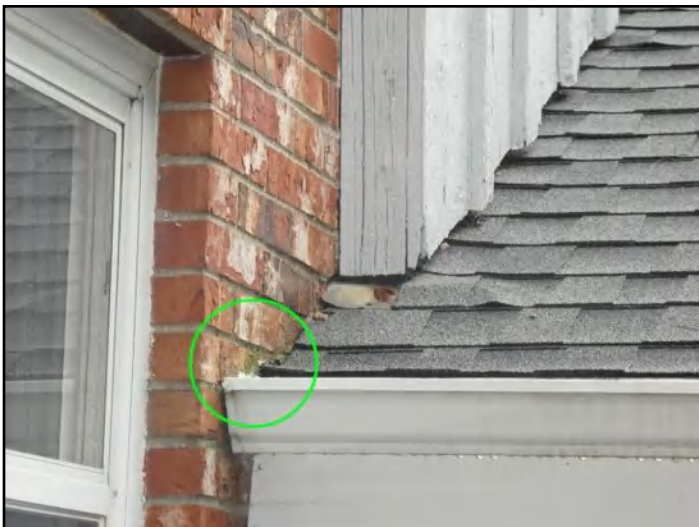
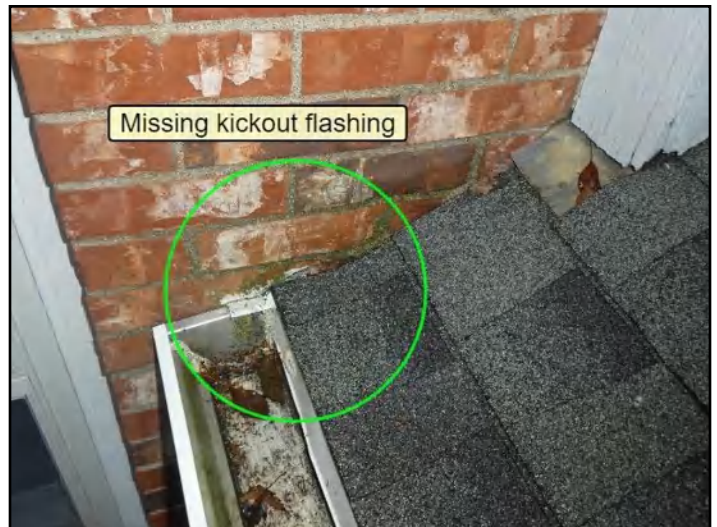
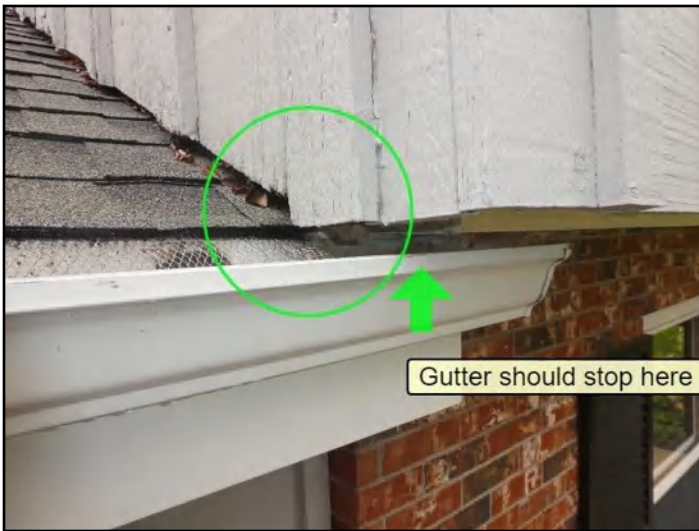
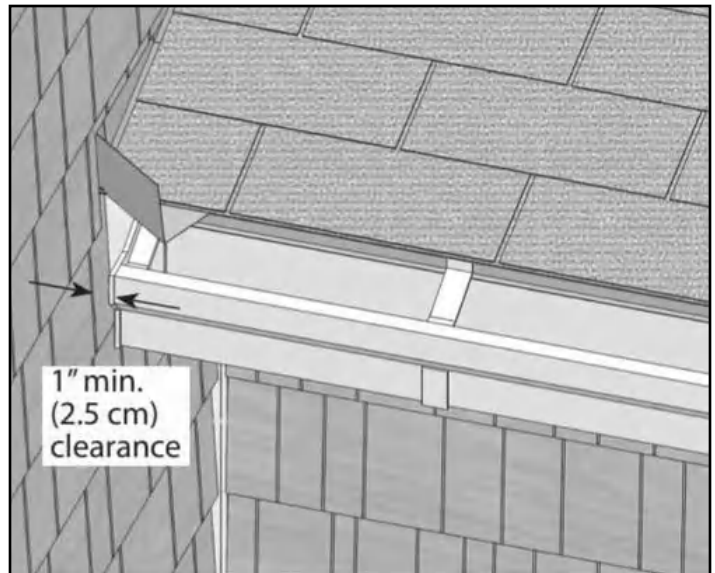
Condition: • No kick-out flashing

There is no kickout flashing where there should be. Also the gutter on the roof will trap water under the second floor overhang. Potential for wood rot.

7. No kick-out flashing

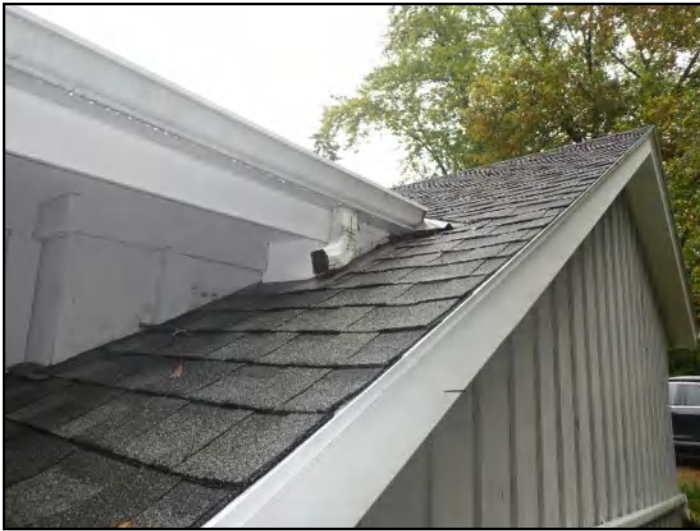
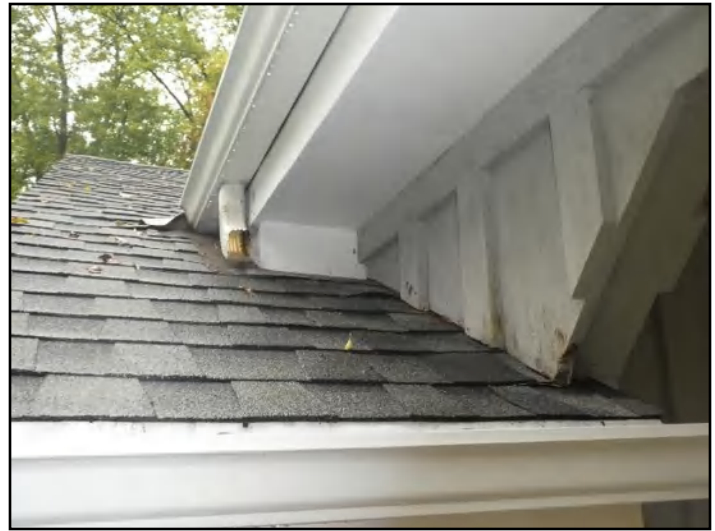
Condition: • [Discharge onto roofs](#)

Implication(s): Chance of water damage to structure, finishes and contents

11. Discharge onto roofs

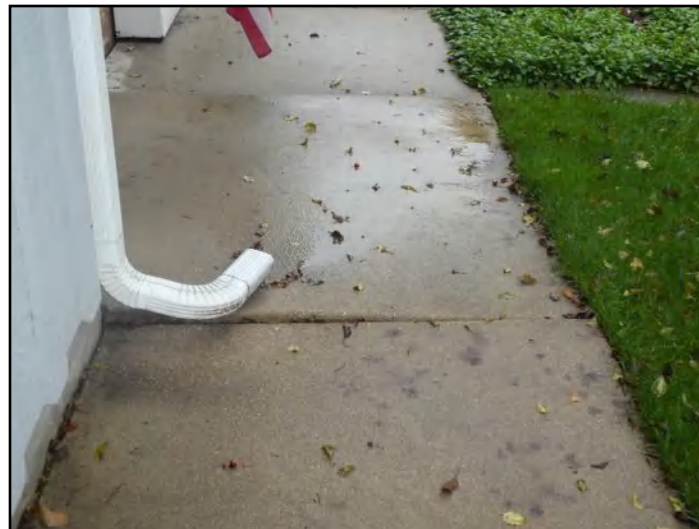
Condition: • Downspout discharges on sidewalk. This needs to be corrected.

Down spouts draining on sidewalk is a trip hazard.

13. Downspout discharges on sidewalk. This...

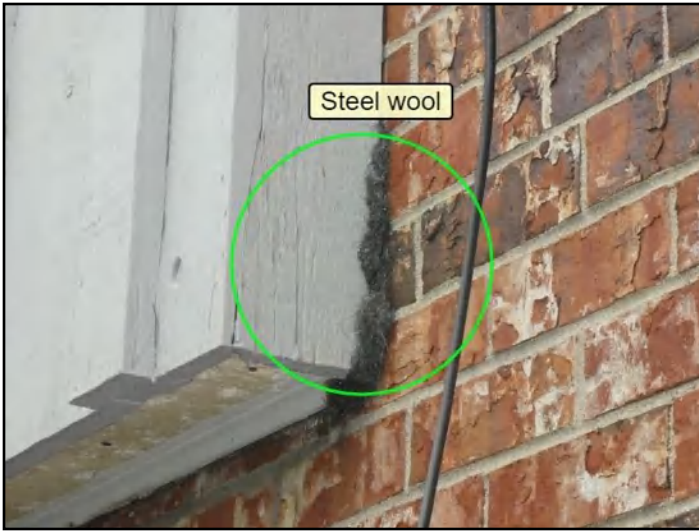
14. Steel wool being used to prevent animal entry

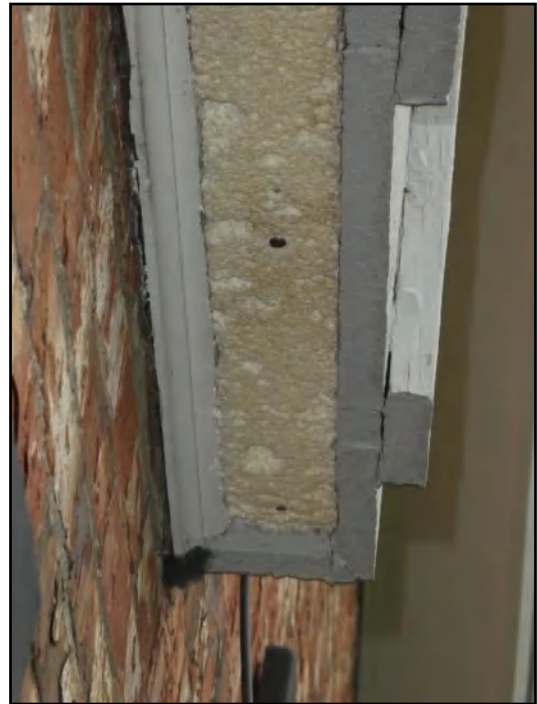
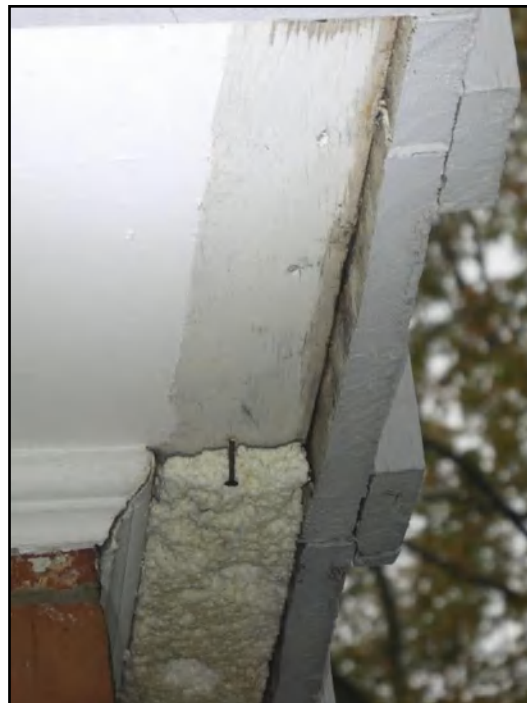
Condition: • Visible insulation on right side of home below the second story. This should be properly covered with wood.

15. Visible insulation

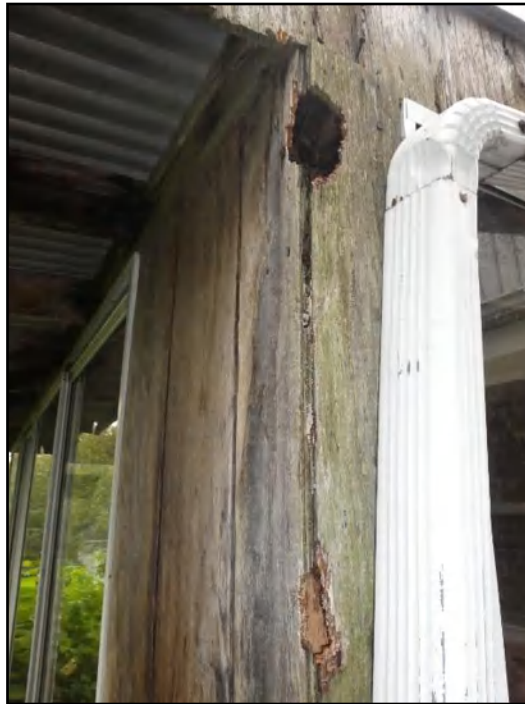
17. Animal damage

Condition: • Animal damage

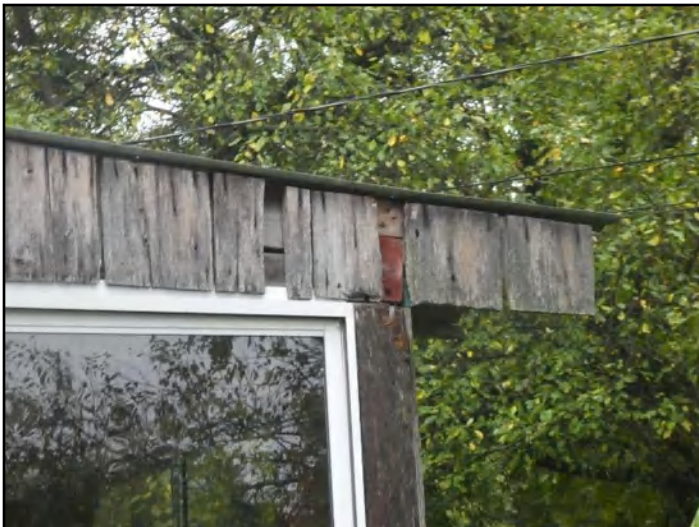
18. Wood rot

Condition: • Wood rot

Wood rot visible on 3 season room.

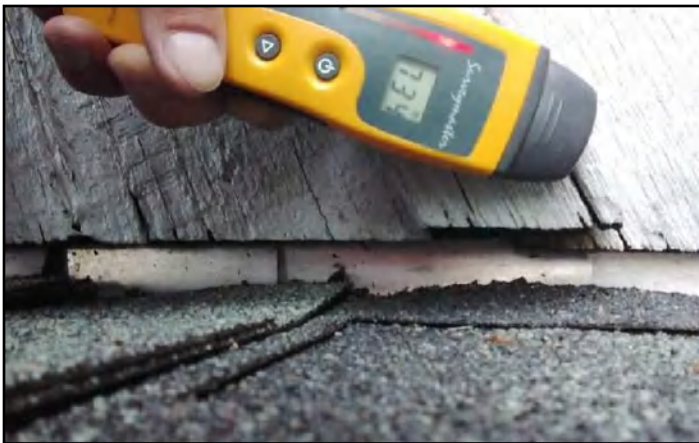
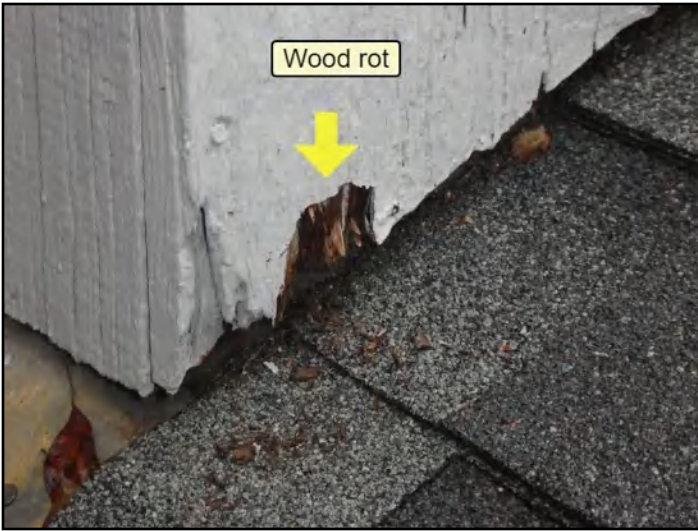
Condition: • The bottom few inches of the wood siding on the second story is rotting due to age and lack of maintenance.

22. High moisture in siding

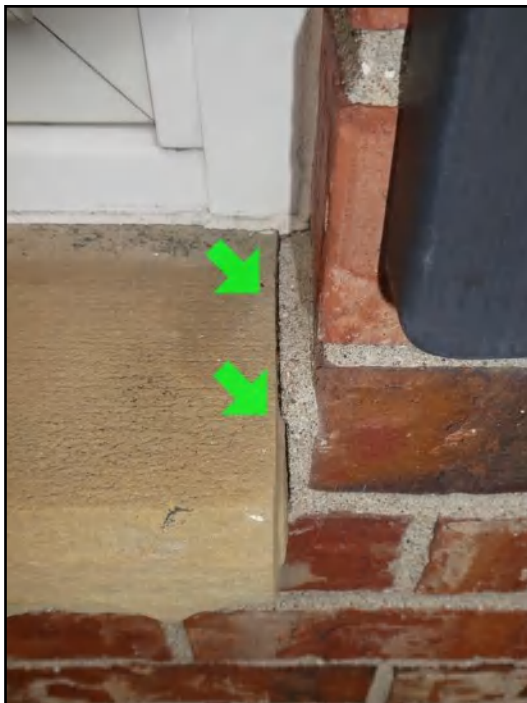
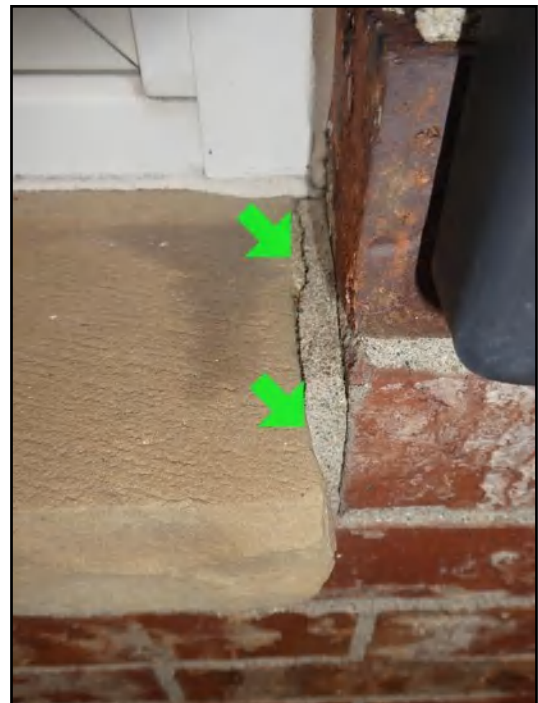
Condition: • Limestone sill

The window sills need to be properly mortared to the home. The current mortar is cracking which will allow water to penetrate behind the brick and cause future damage.

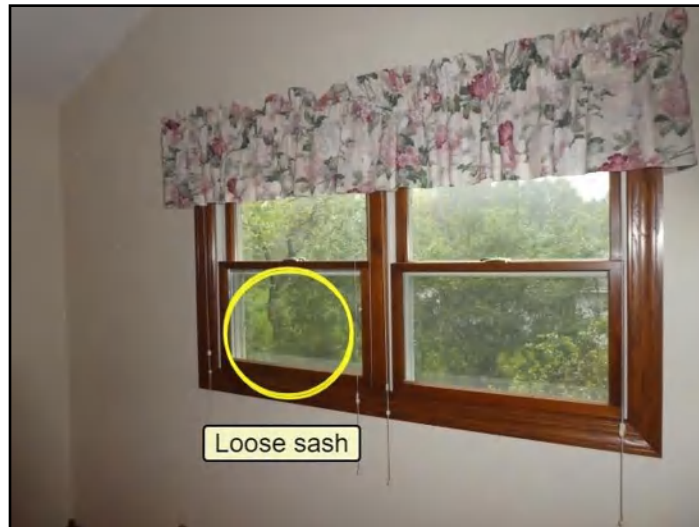
28. Loose fit

Condition: • [Loose fit](#)

Implication(s): Chance of water entering building | Increased heating and cooling costs | Reduced comfort

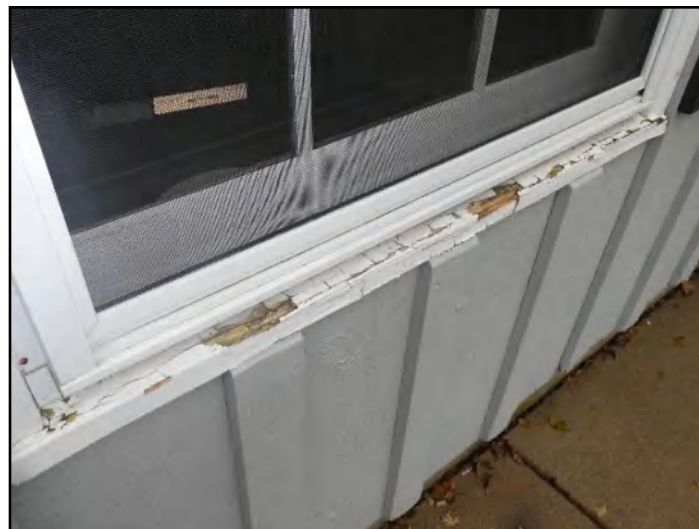
Condition: • Rot

The sill of the window is completely rotten and will need to be replaced.

29. Rotting window sill

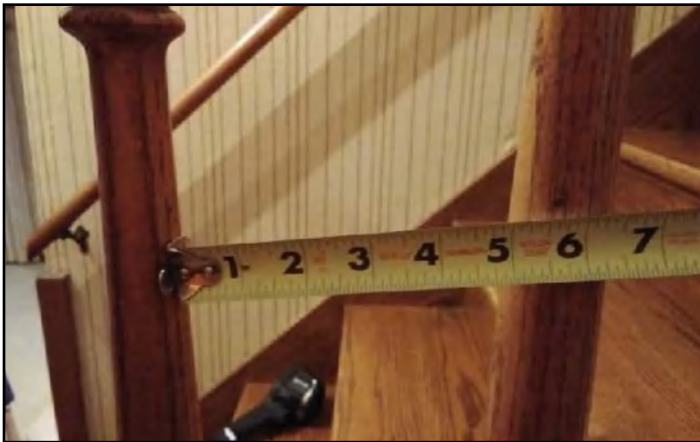
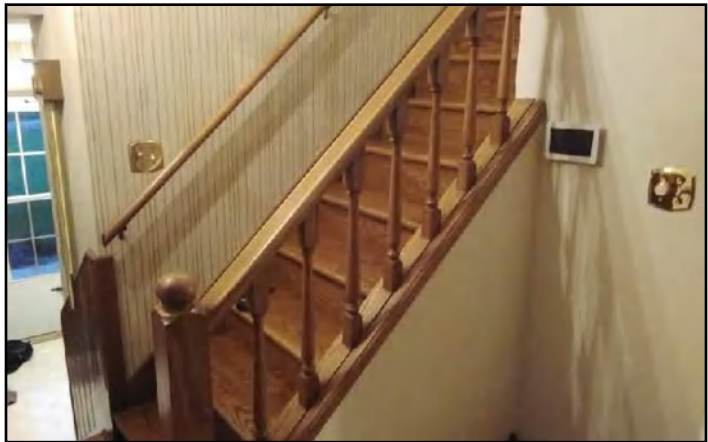
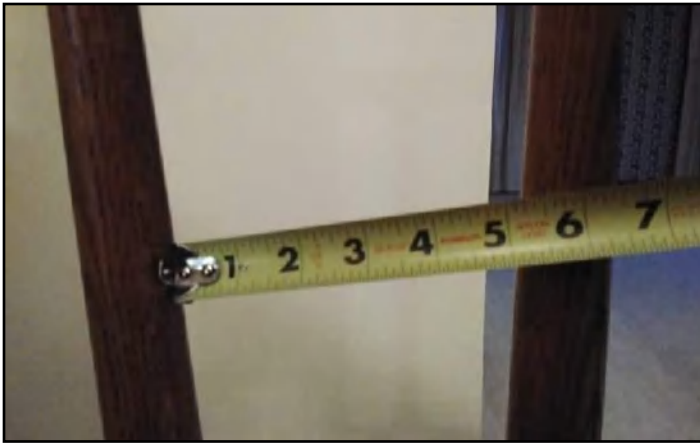
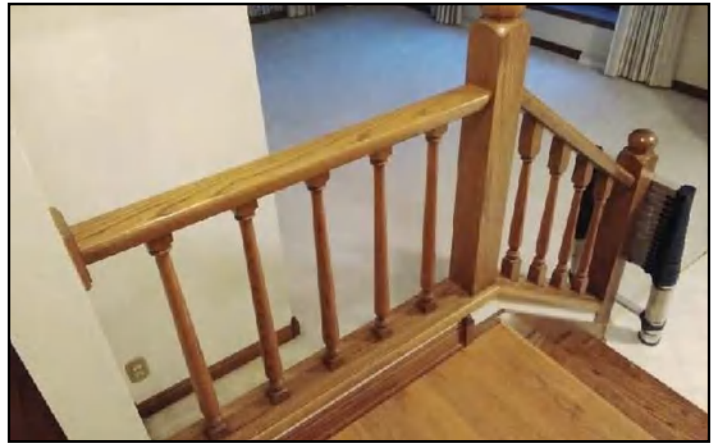
Condition: • [Spindles \(balusters\) too far apart](#)

Implication(s): Fall hazard

30. Spindles (balusters) too far apart

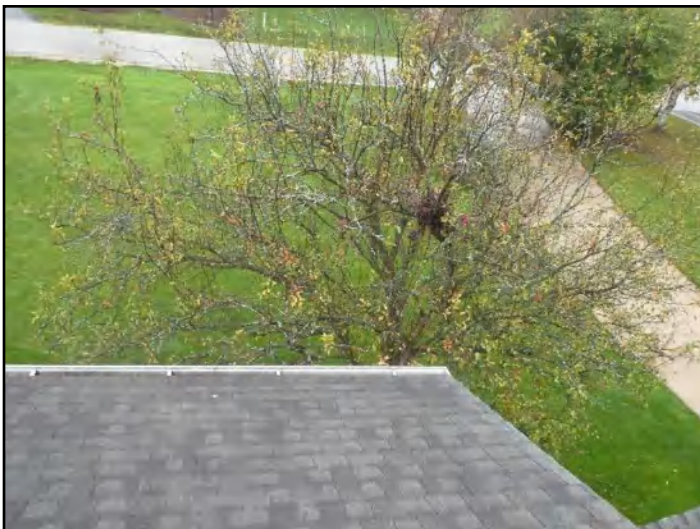
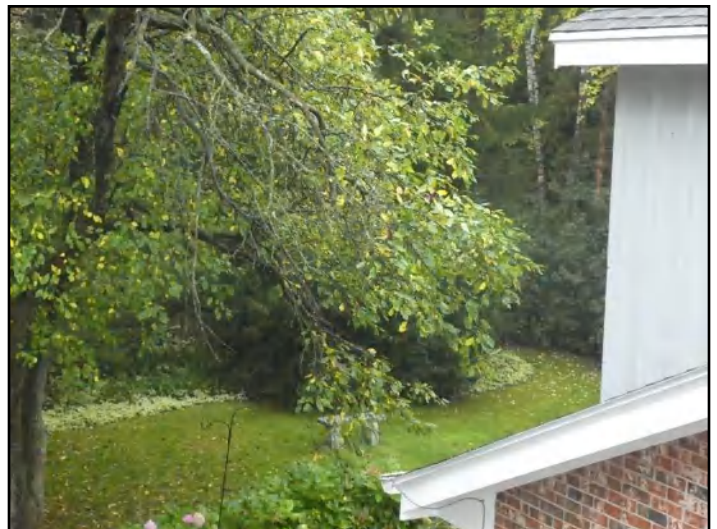
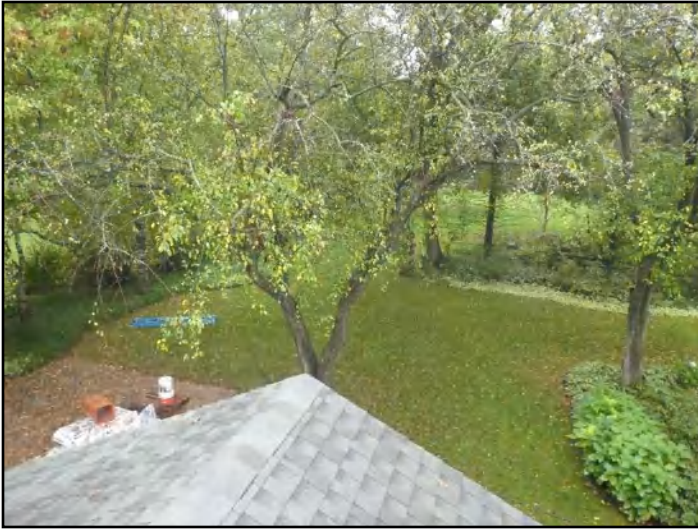
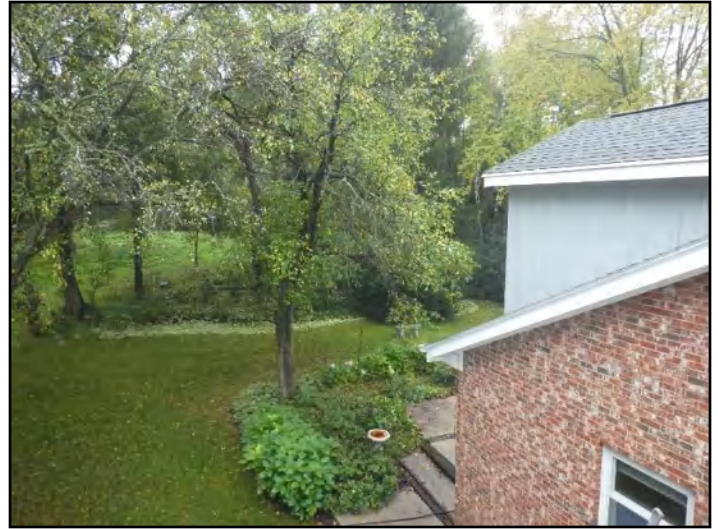
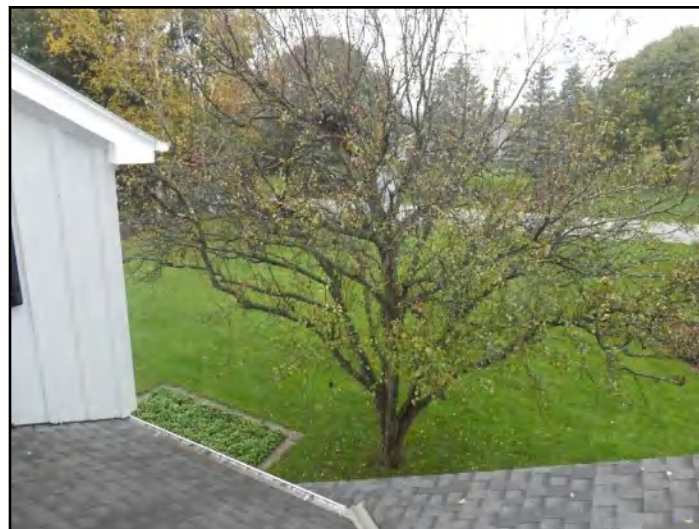
Condition: • Trees to close to house. Trim back.

34. Trees to close to house. Trim back.

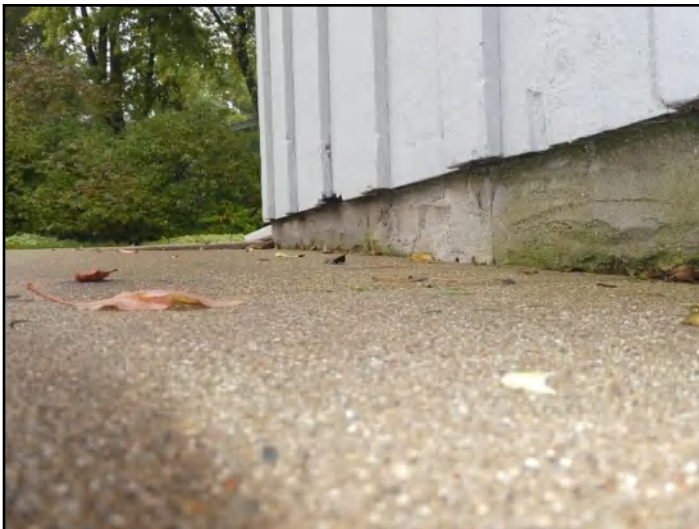
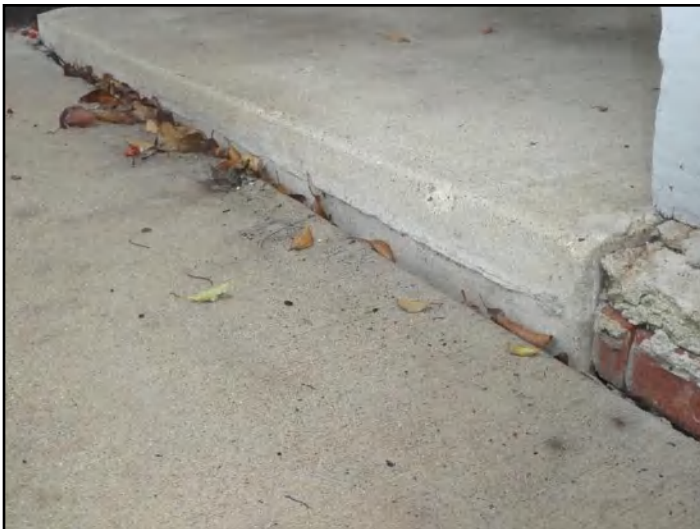
Condition: • [Improper slope or drainage](#)

The walkway from the driveway to the front door has dropped, sagged and improperly sloped. This will need to be addressed as additional water is penetrating the foundation and is visible on the interior of the home.

Implication(s): Chance of water damage to structure, finishes and contents

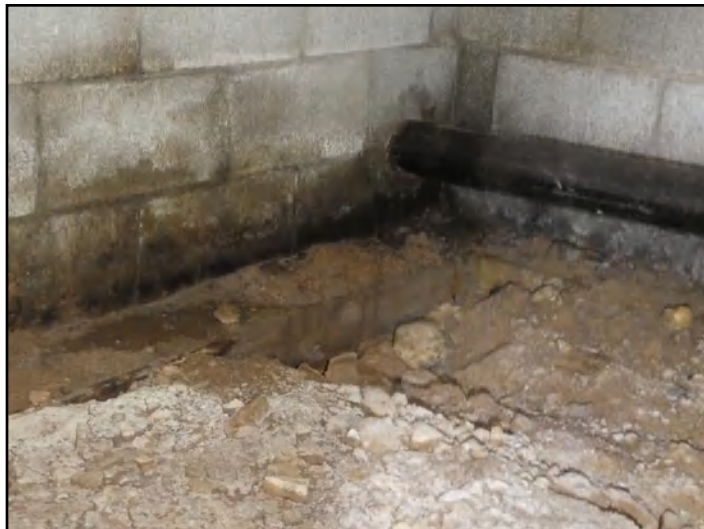
52.

Condition: • Visible water on foundation wall.

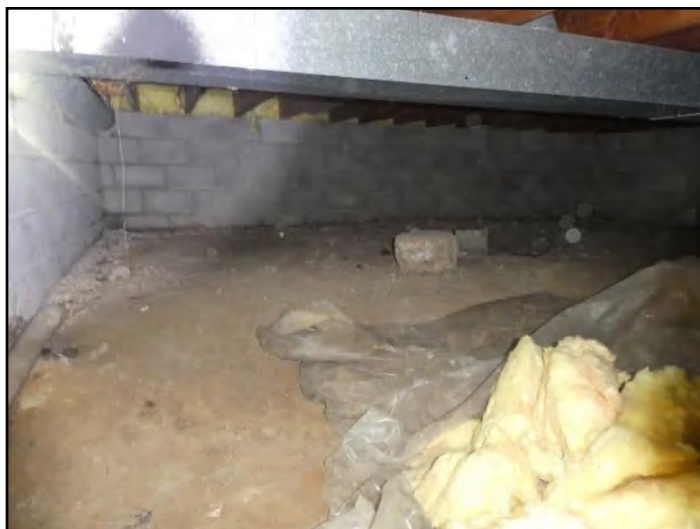
53. Dirt floor in crawl space

Condition: • Dirt floor in crawl space

The dirt floor will need to be corrected due to the high radon levels in basement.

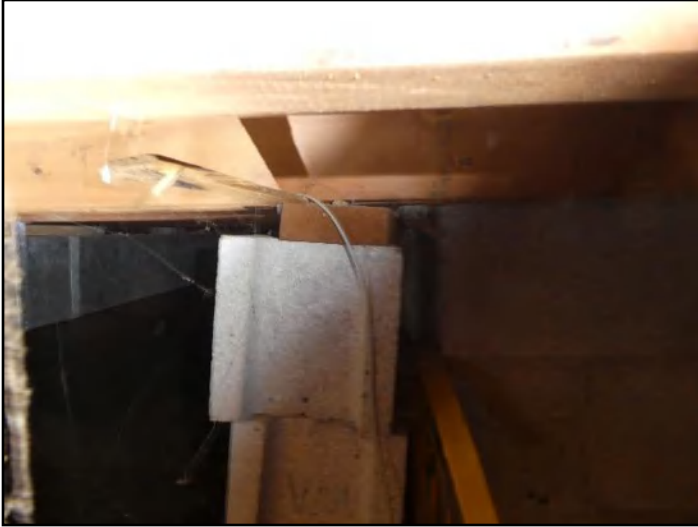
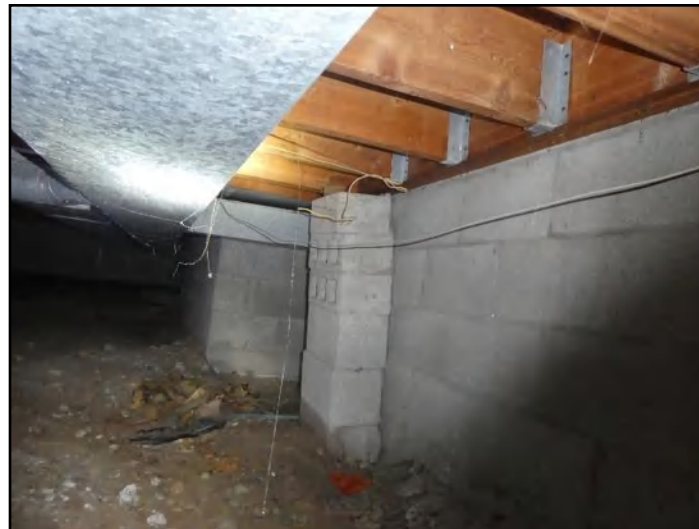
Condition: • Improper support

Cement block on unstable soil used for supports. Remove and correct by a licensed contractor.

54. Improper support

56. Improper support

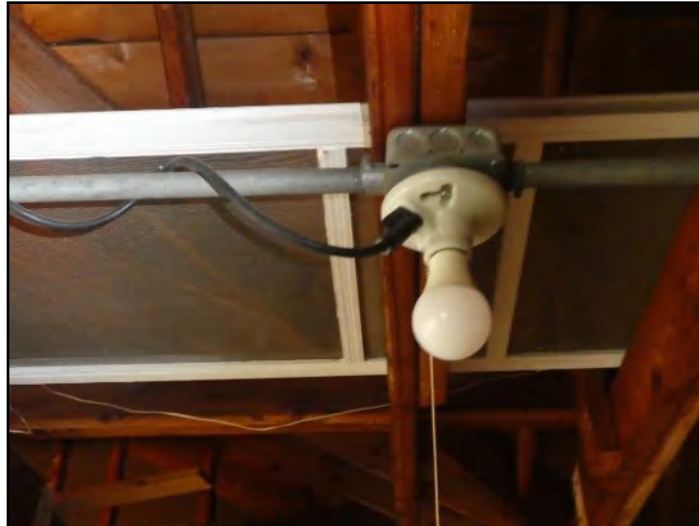
Condition: • Garage door opens needs dedicated outlet

57. Open needs own outlet

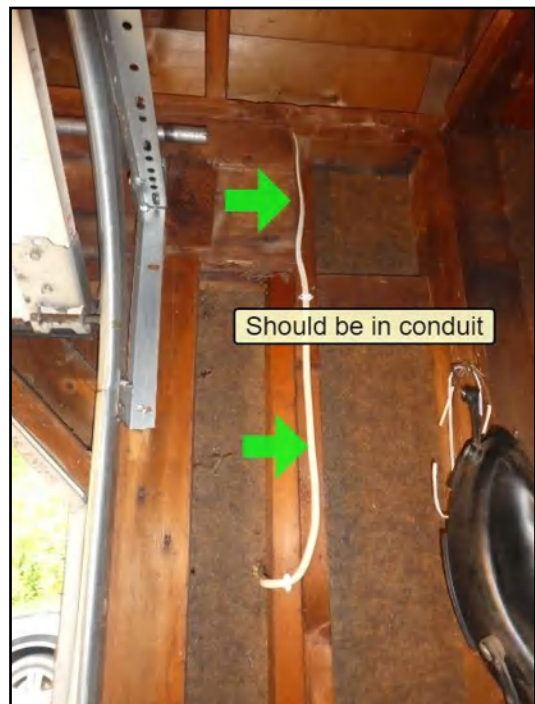
Condition: • Unprofessional work. Consult licensed electrician to correct issues.

59. Unprofessional work. Consult licensed...

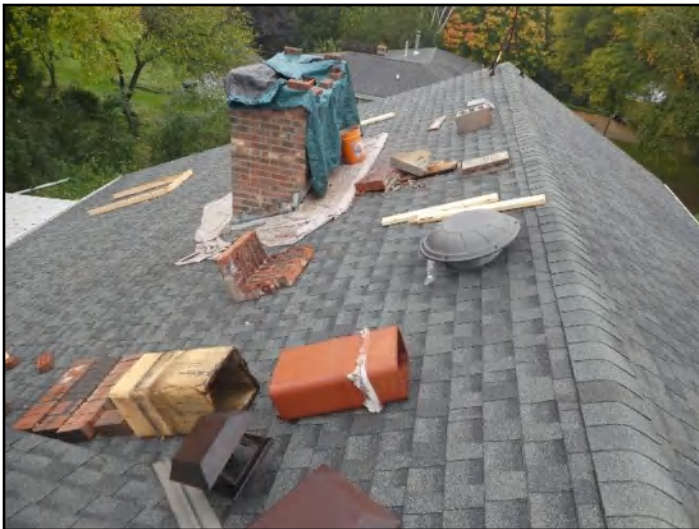
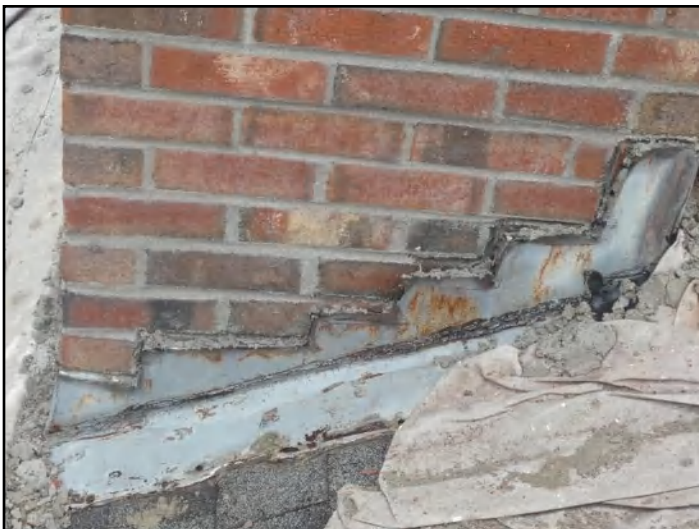
Condition: • Being rebuilt. The visible flue needs attention. Also the clay liner below the new one is cracked and should be replaced. A flue liner is also needed for the water heater and will need to be installed.

60. Chimney rebuild

62. Chimney rebuild

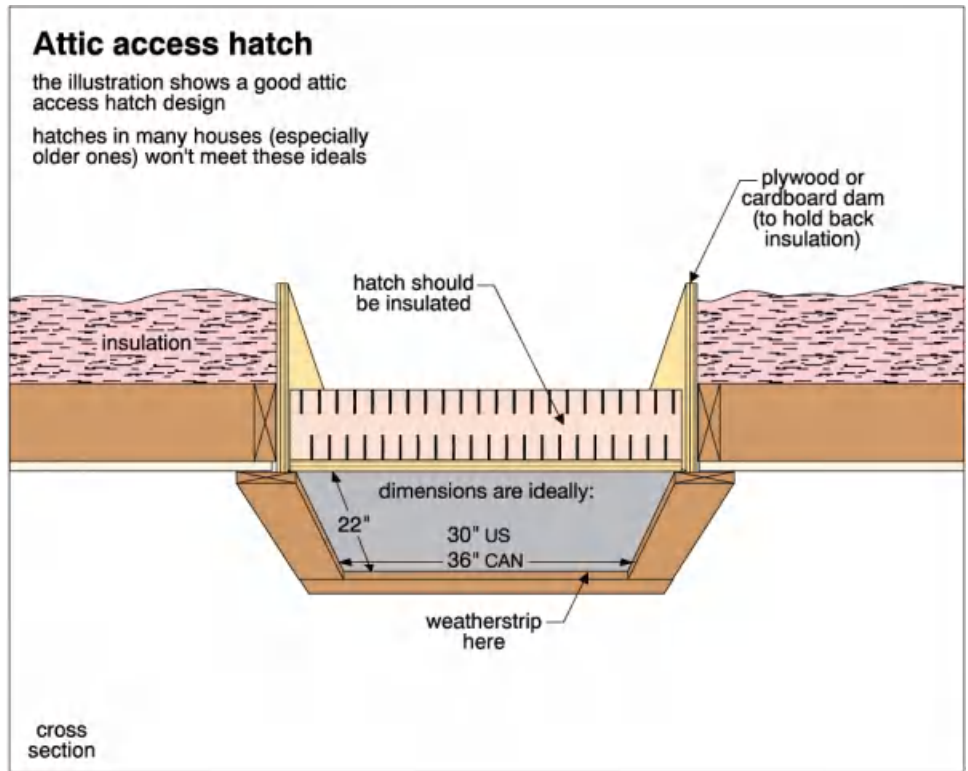
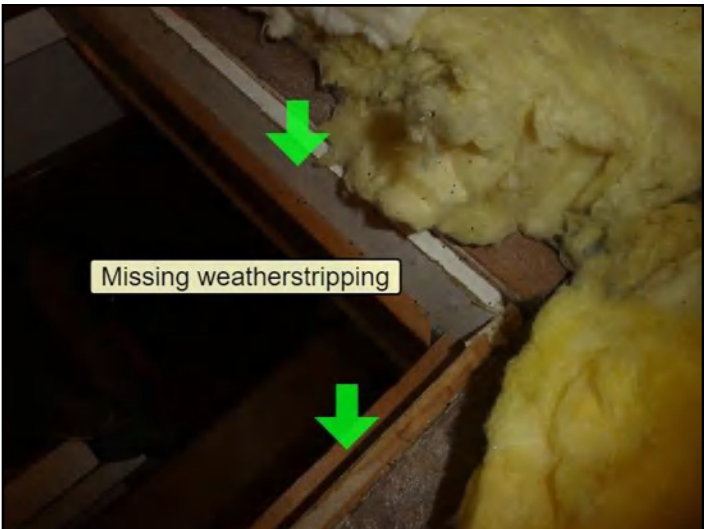
Condition: • [Not weatherstripped](#)

Implication(s): Chance of condensation damage to finishes and/or structure | Increased heating and cooling costs

65. Not weatherstripped

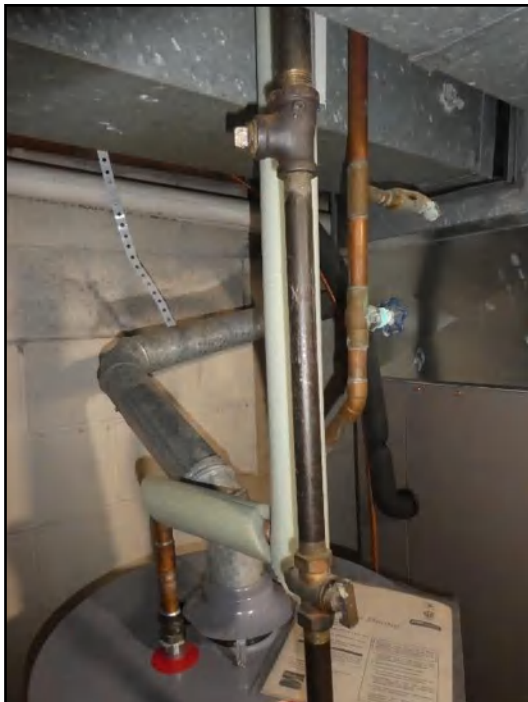
71.

Condition: • Corrosion at valve. Leaking and should be replaced.

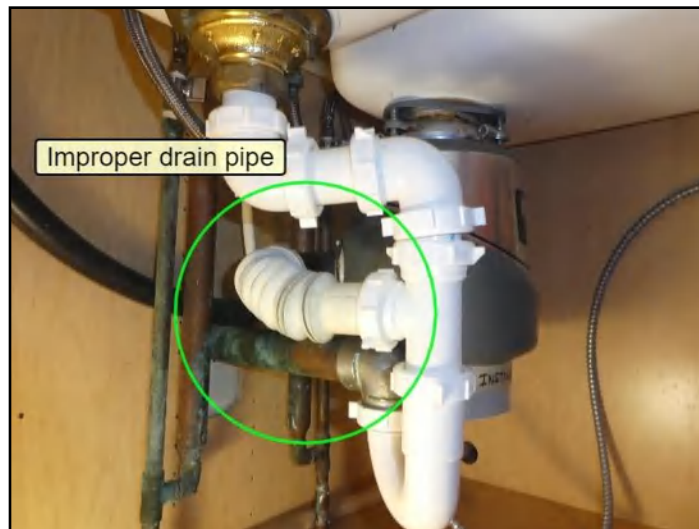
Condition: • [Nonstandard materials and patches](#)

Implication(s): Chance of water damage to structure, finishes and contents | Sewage entering the building

74. *Nonstandard materials and patches*

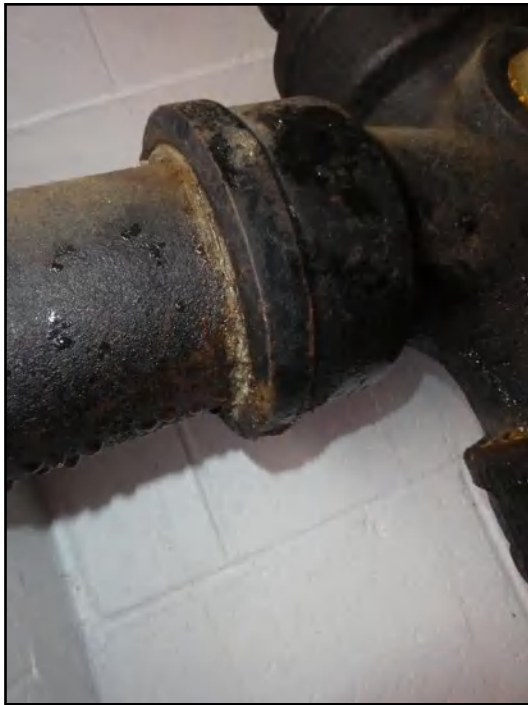
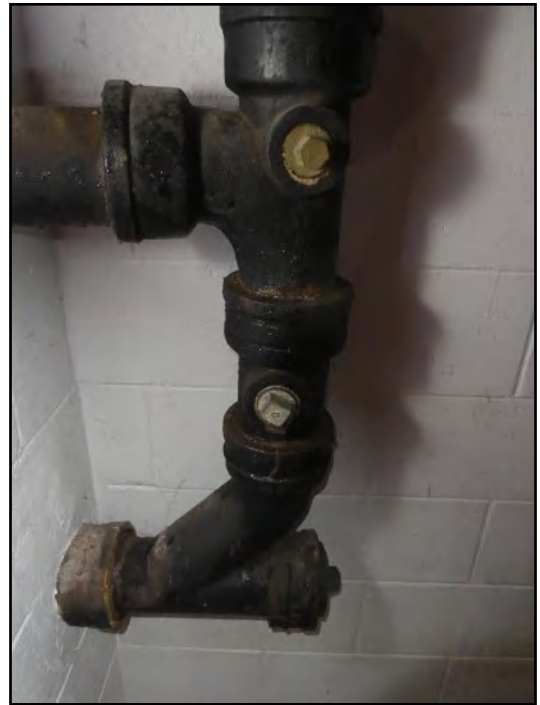
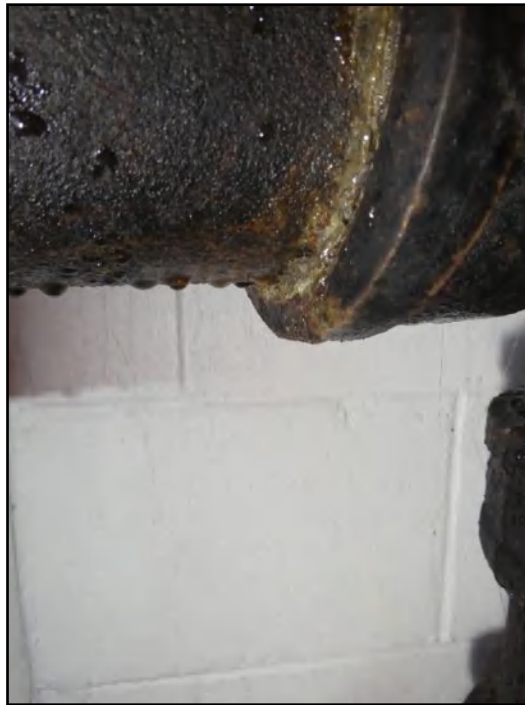
Condition: • Cast iron main stack

75. Cast iron main stack

76. Cast iron main stack

77. Cast iron main stack

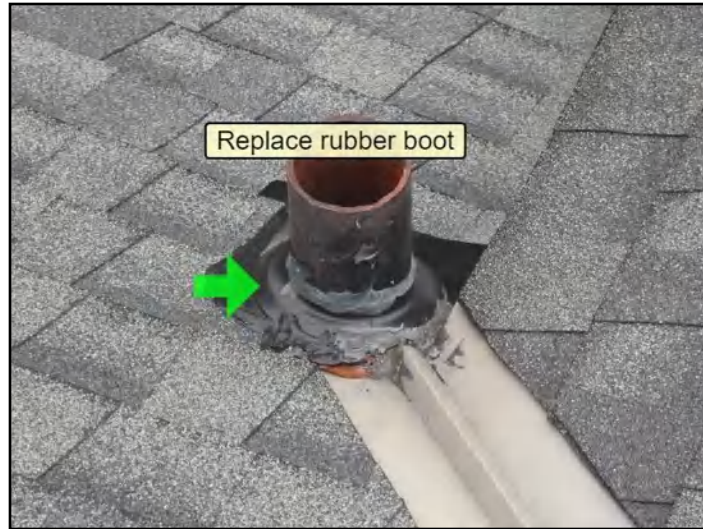
Condition: • Poor location for vent stack. Should replaced rubber boot as the repairs to rubber gasket are excessive.

78. Vent stack

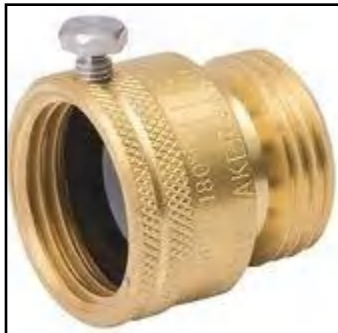
Condition: • Missing back flow preventor

79. Missing back flow preventor

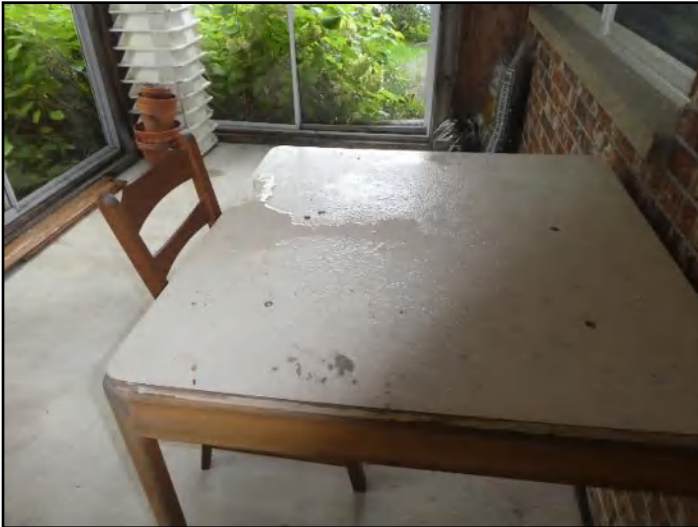
1. Condition: • [Leak](#)

The roof of the 3 season room leaks. This will need to be resealed.

Implication(s): Chance of water damage to structure, finishes and contents

84. Leak

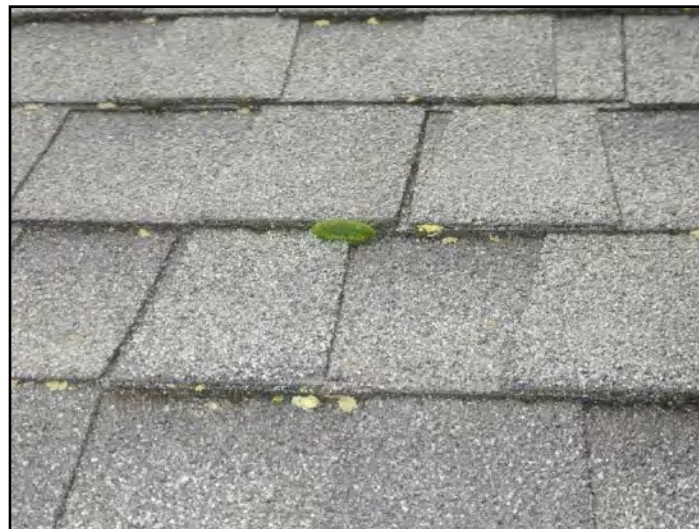
3. Condition: • Moss visible on shingles

86. Moss, mildew, etc.

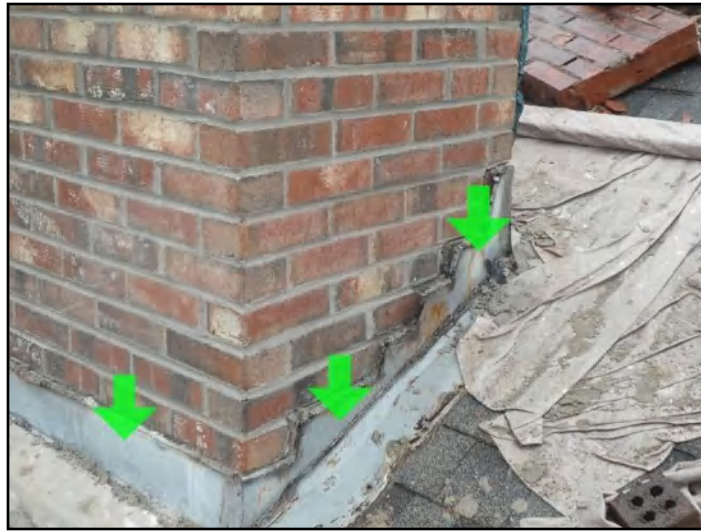
4. Condition: • Chimney being rebuilt. New flashed should be installed. Remove old flashing.

87. Old flashing

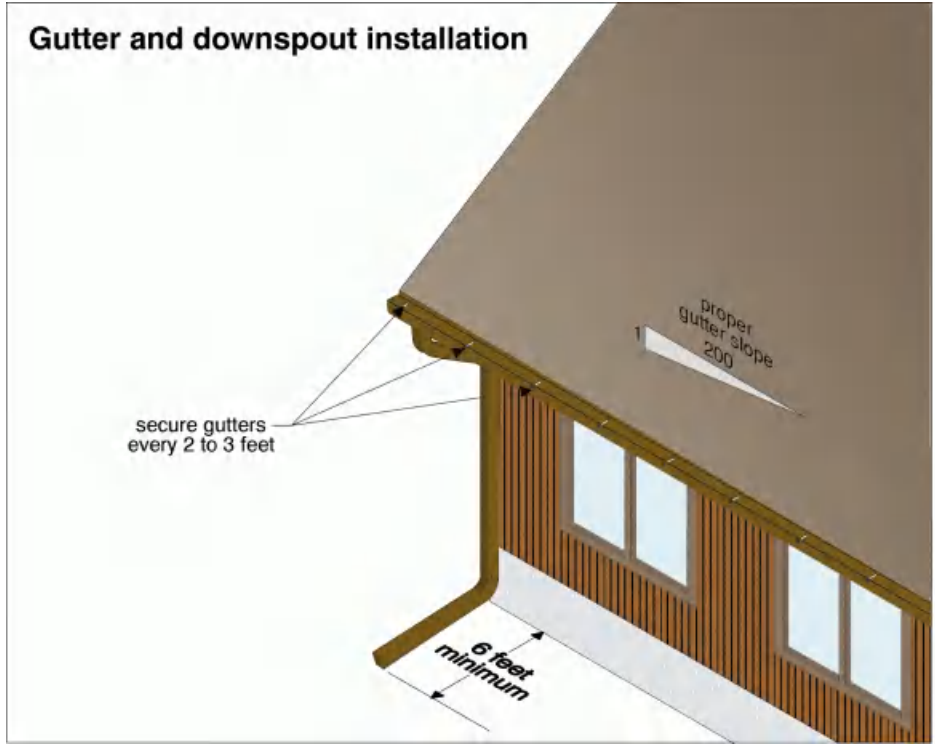
5. Condition: • [Missing](#)

missing gutter on the dormer for the second floor room. They should be installed to prevent splash on wood siding. Help to prevent wood rot.

Implication(s): Chance of water damage to structure, finishes and contents

88. Missing gutters

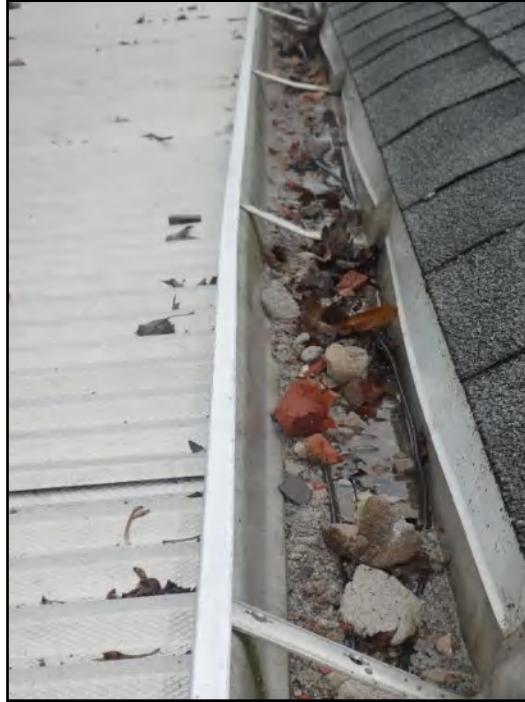
6. Condition: • Dirty/debris

Debris from chimney rebuilt in gutters. This needs to be fully removed.

89. Dirty/debris
