INSPECTION REPORT

For the Property at:
2222 SUNNYSLOPE RD
MEQUON, WI 53097

Prepared for: MR. & MRS. SMITH
Inspection Date: Thursday, July 7, 2023
Prepared by: Michael Schwitzer

1st Choice Inspection
1603 Rockridge Way
Waukesha, WI 53188
414-803-9678

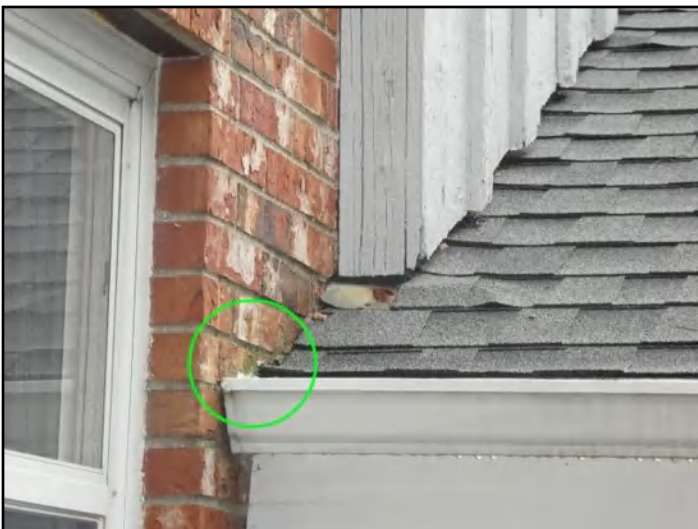
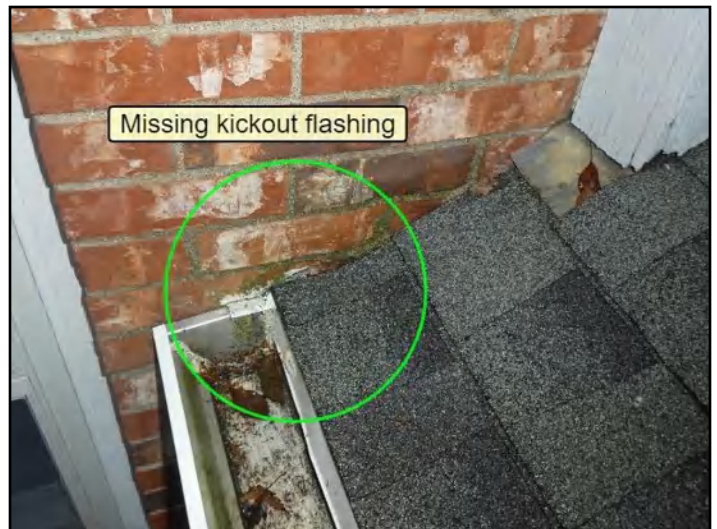
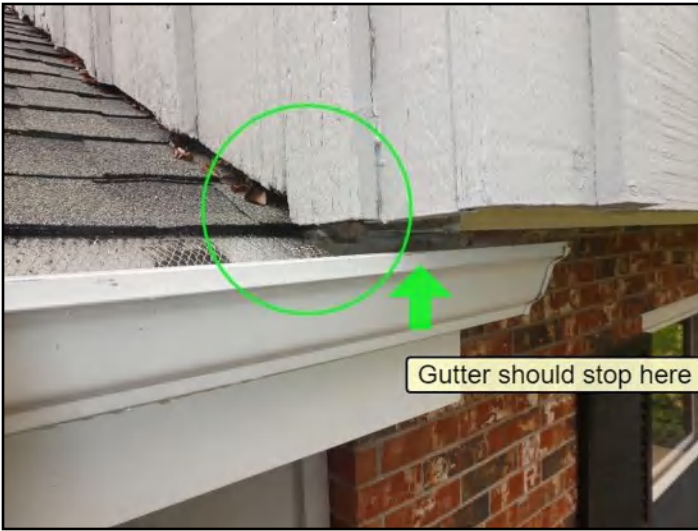
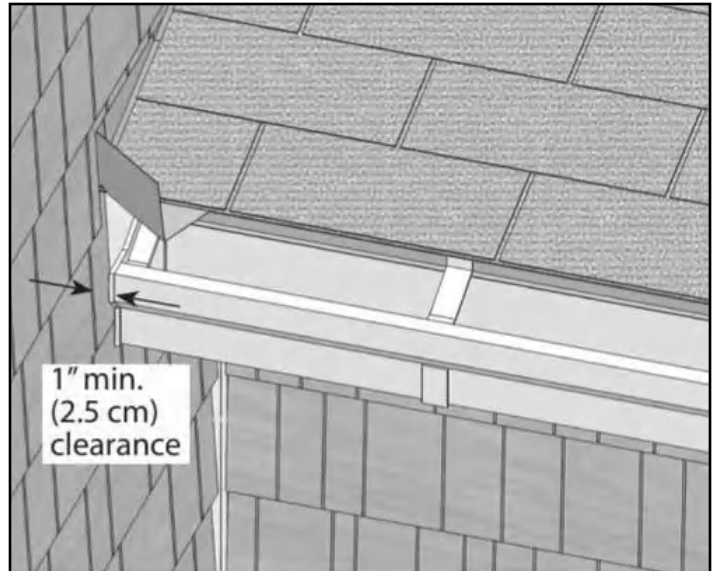
7. Condition: • No kick-out flashing

There is no kickout flashing where there should be. Also the gutter on the roof will trap water under the second floor overhang. Potential for wood rot.

90. No kick-out flashing

91. No kick-out flashing

92. No kick-out flashing

93. No kick-out flashing

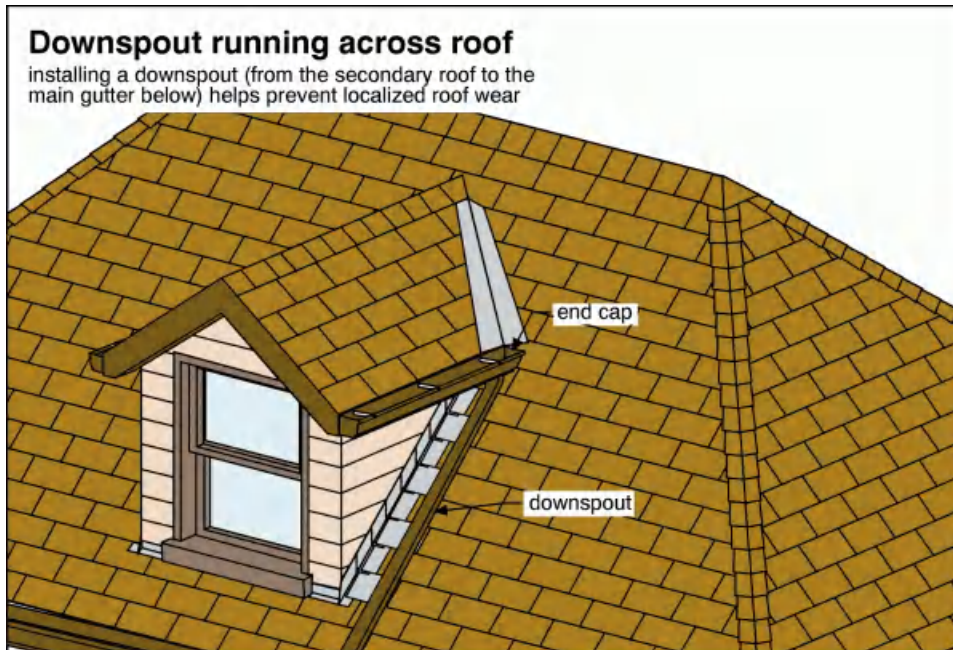
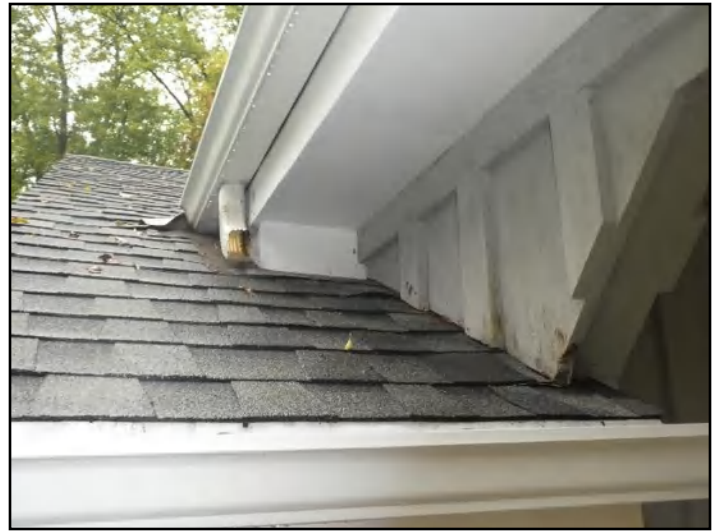
8. Condition: • [Discharge onto roofs](#)

Implication(s): Chance of water damage to structure, finishes and contents

95. Discharge onto roofs

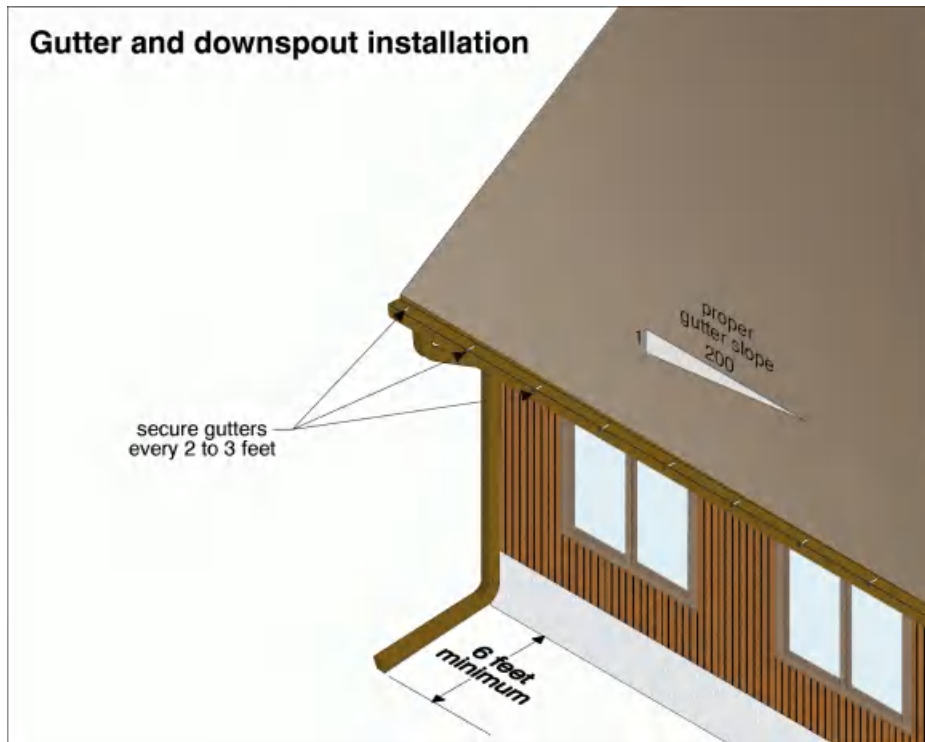
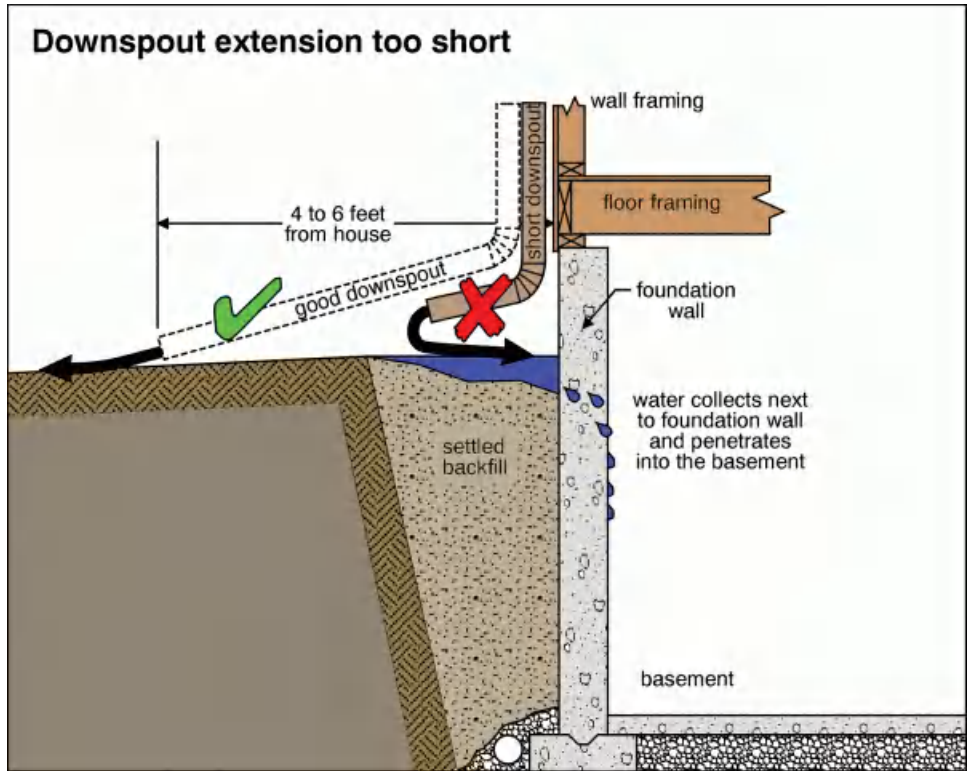
9. Condition: • [Should discharge 6 feet from building](#)

Implication(s): Chance of water damage to structure, finishes and contents

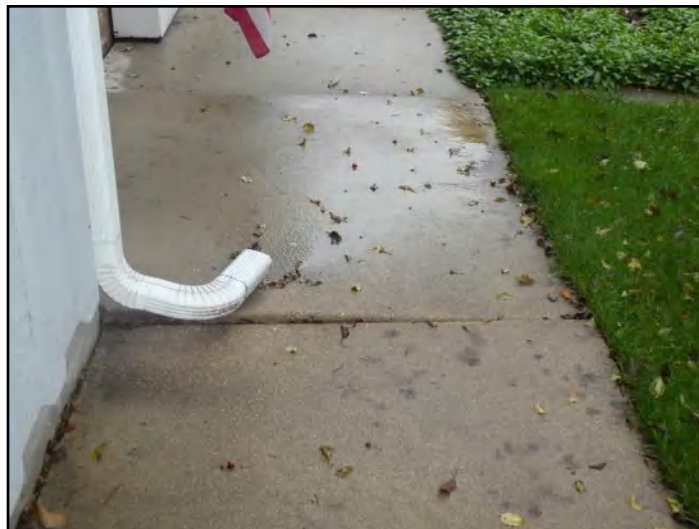
10. Condition: • Downspout discharges on sidewalk. This needs to be corrected.

Down spouts draining on sidewalk is a trip hazard.

96. Downspout discharges on sidewalk. This...

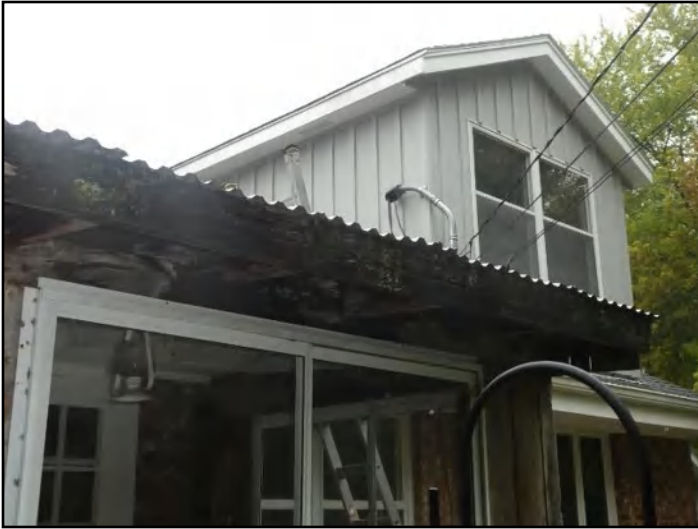
12. Condition: • Wood rot

Wood rot visible on 3 season room.

100. Wood rot

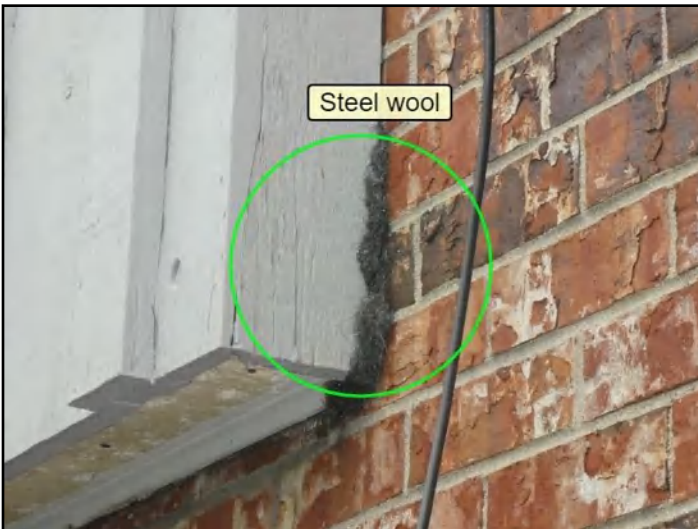
13. **Condition:** • Animal damage

102. Steel wool being used to prevent animal entry

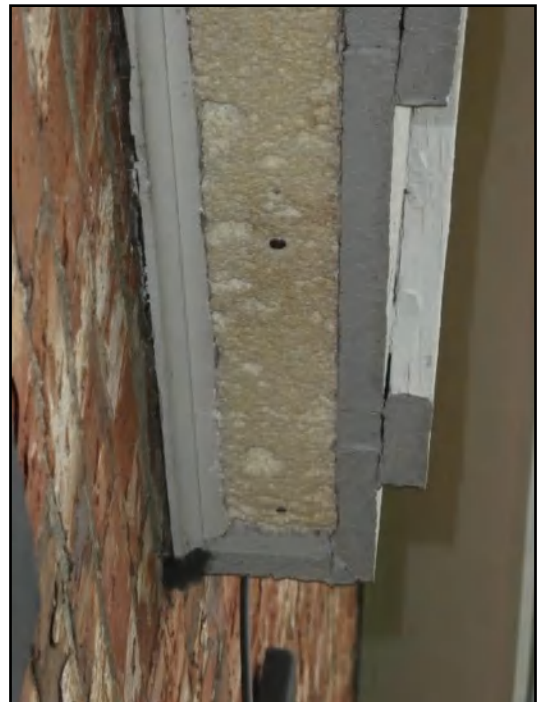
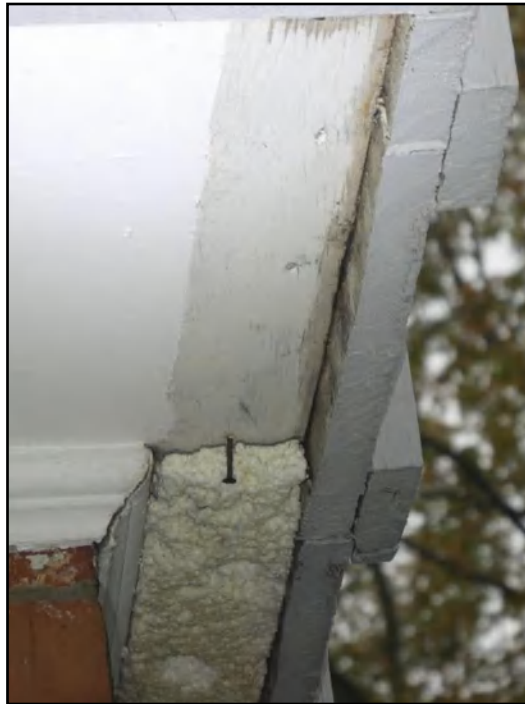
15. **Condition:** • Visible insulation on right side of home below the second story. This should be properly covered with wood.

103. Visible insulation

104. Visible insulation

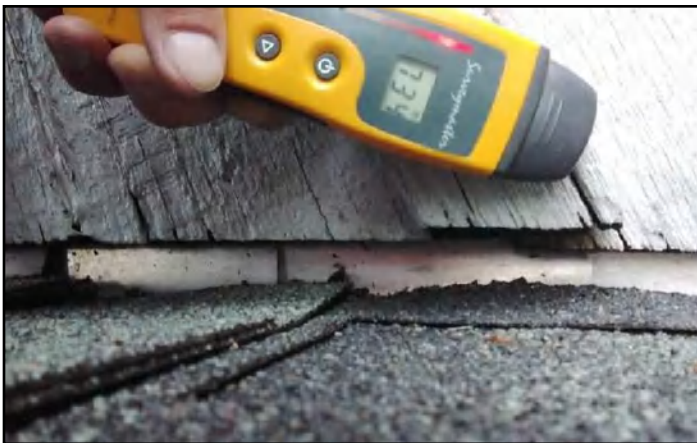
16. Condition: • The bottom few inches of the wood siding on the second story is rotting due to age and lack of maintenance.

105. High moisture in siding

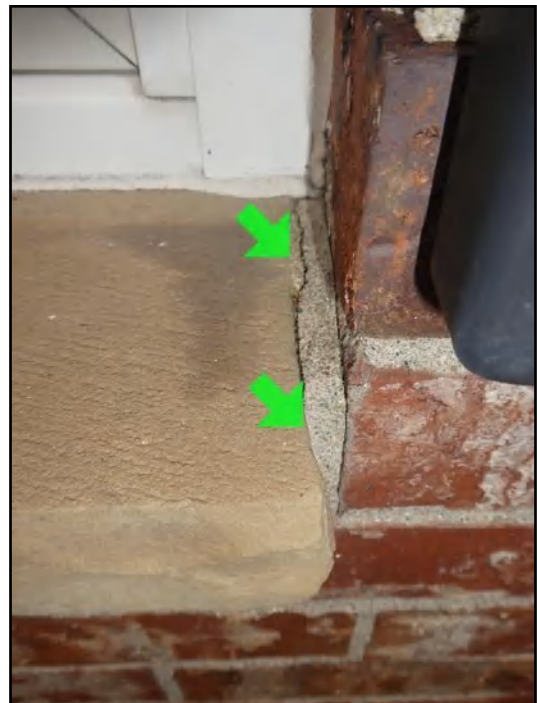
17. Condition: • Limestone sill

The window sills need to be properly mortared to the home. The current mortar is cracking which will allow water to penetrate behind the brick and cause future damage.

108. Limestone sill

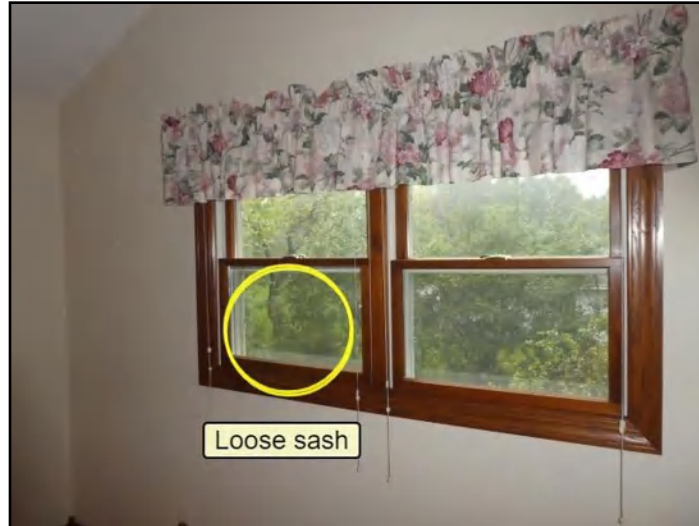
18. Condition: • [Loose fit](#)

Implication(s): Chance of water entering building | Increased heating and cooling costs | Reduced comfort

111. Loose fit

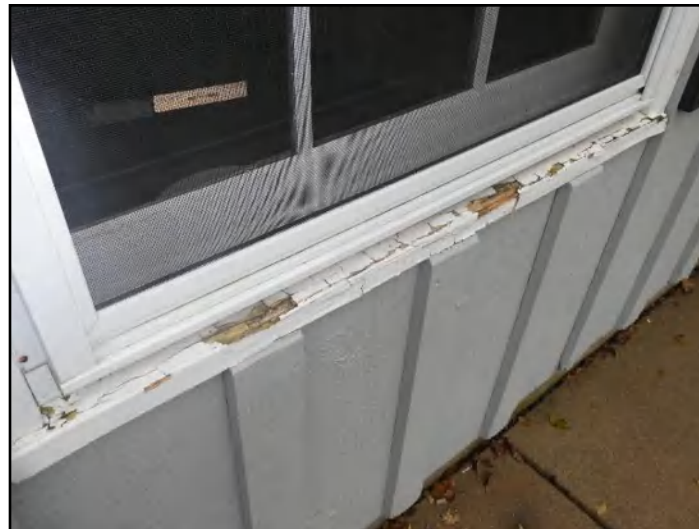
19. Condition: • Rot

The sill of the window is completely rotten and will need to be replaced.

Implication(s): Material deterioration

112. Rotting window sill

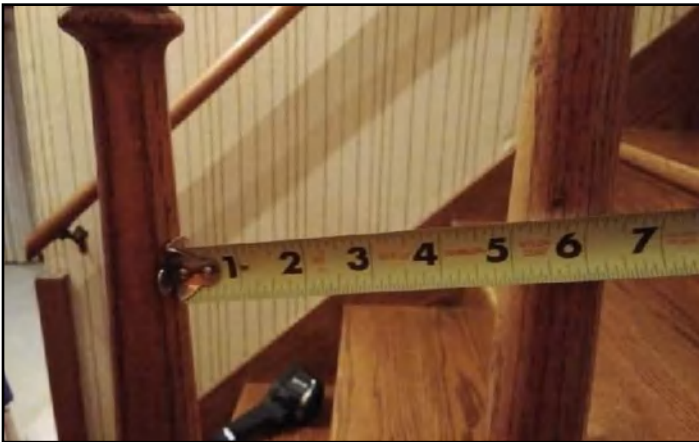
113. Spindles (balusters) too far apart

20. Condition: • [Spindles \(balusters\) too far apart](#)

Implication(s): Fall hazard

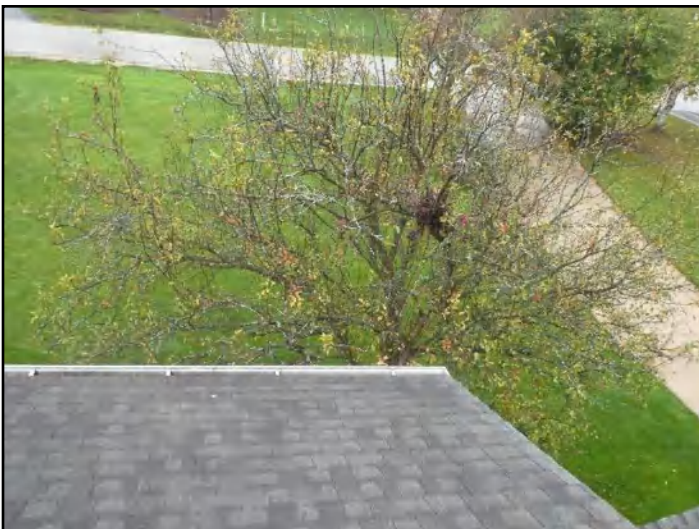
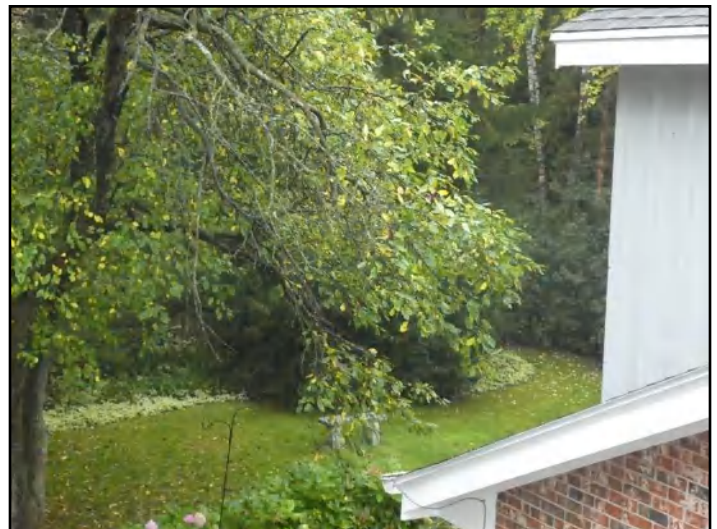
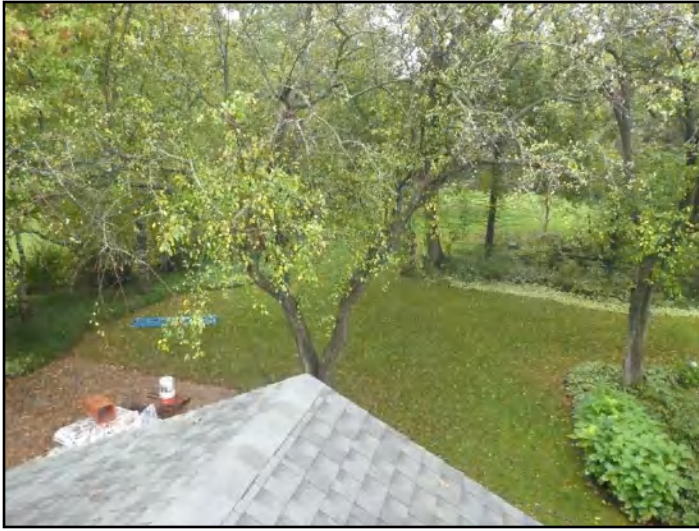
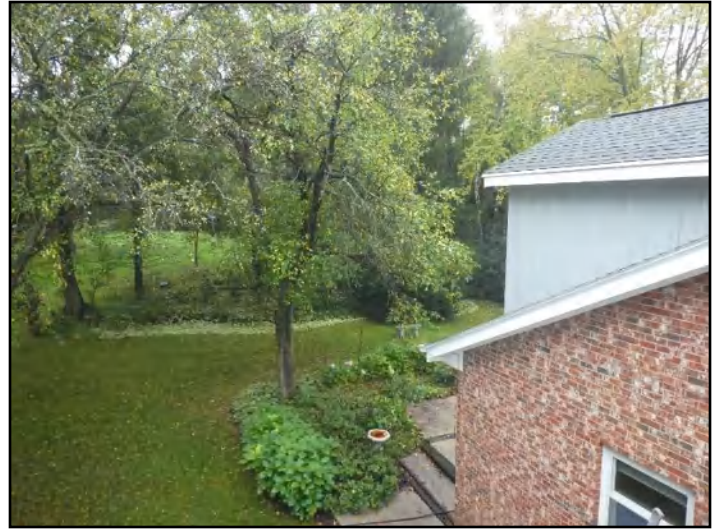
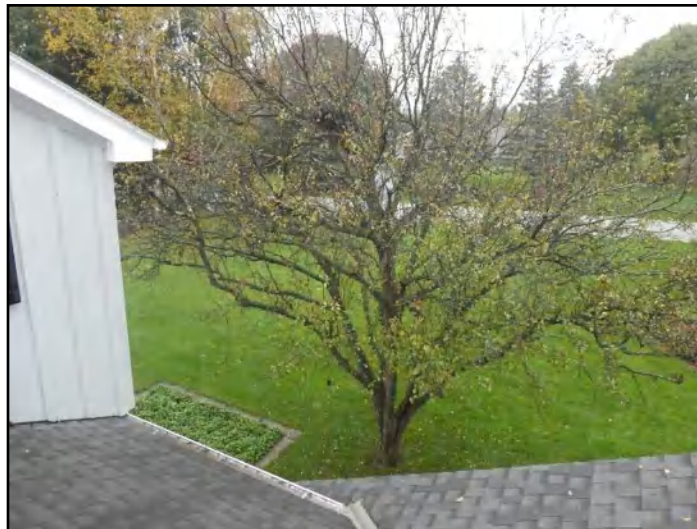
21. Condition: • Trees to close to house. Trim back.

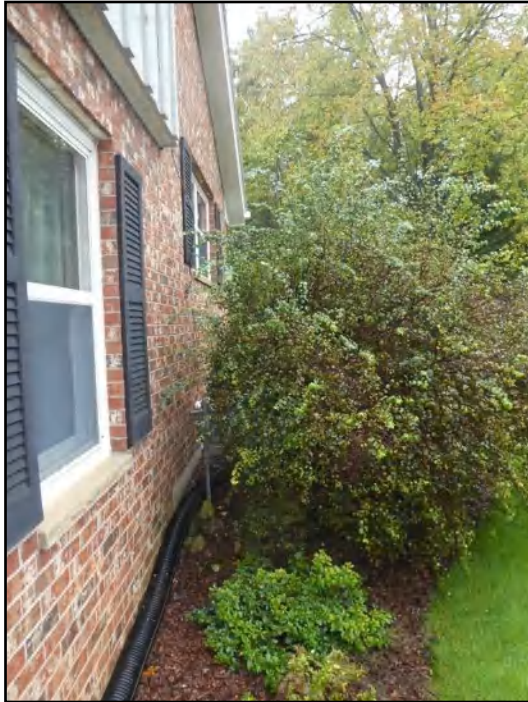
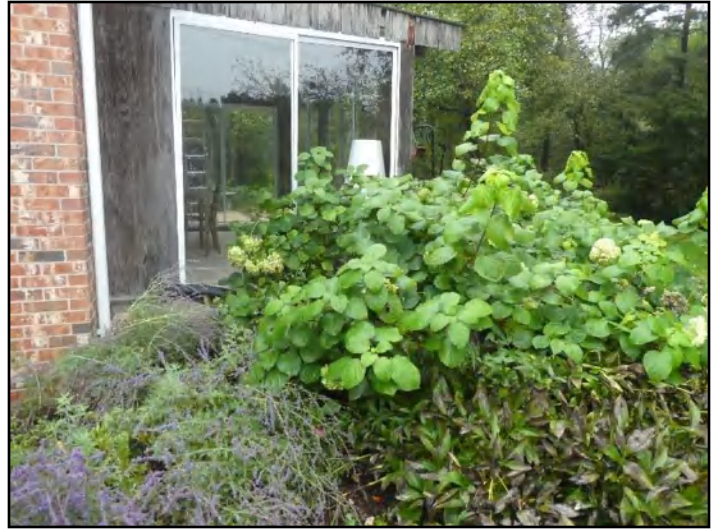
22. Condition: • Shrubs to close to home

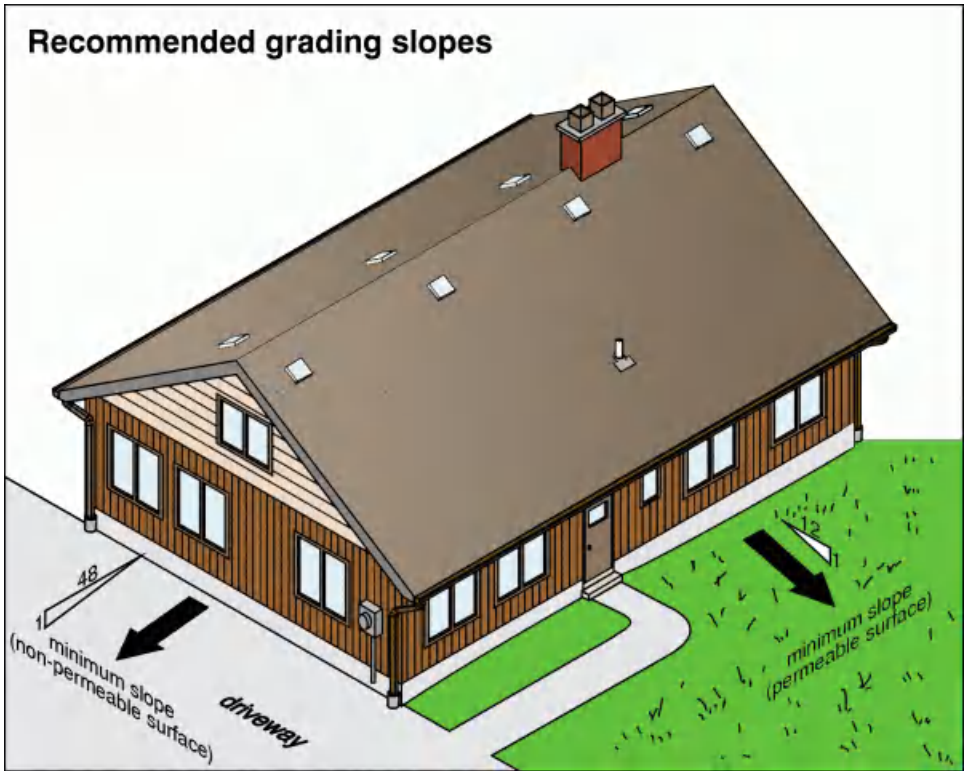
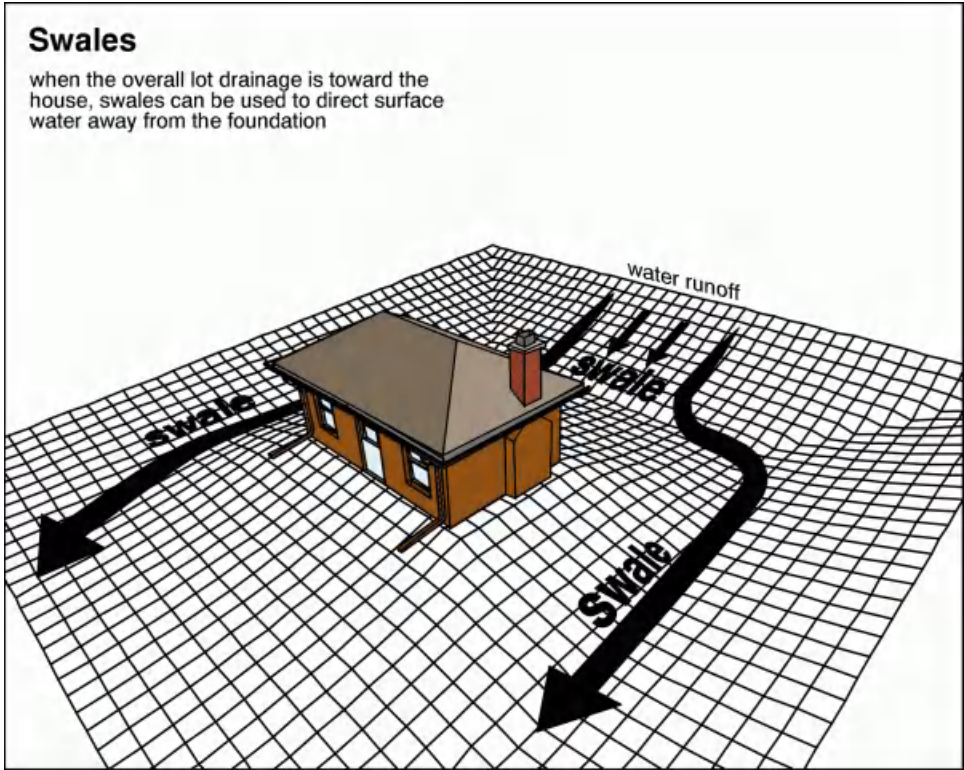
23. Condition: • [Improper slope or drainage](#)

The walkway from the driveway to the front door has dropped, sagged and improperly sloped. This will need to be addressed as additional water is penetrating the foundation and is visible on the interior of the home.

Implication(s): Chance of water damage to structure, finishes and contents

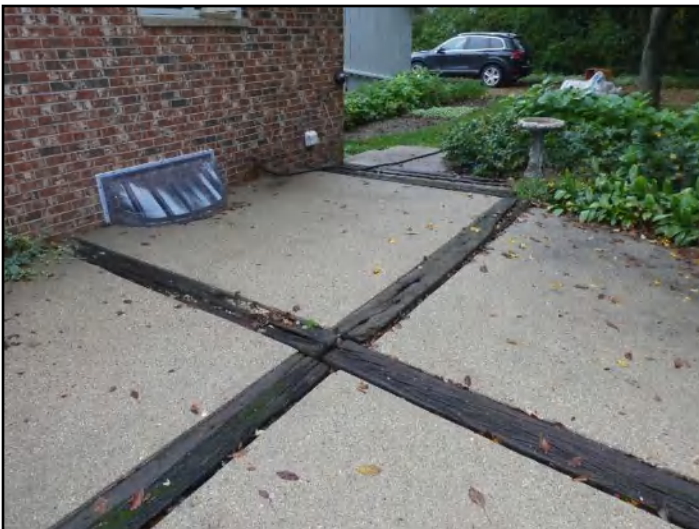
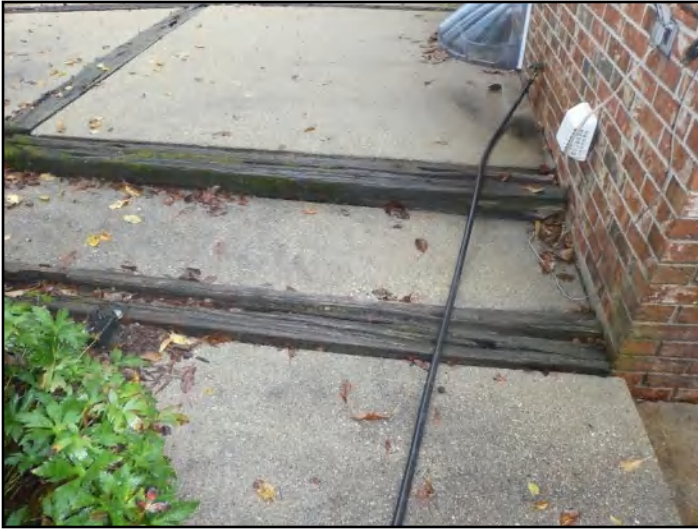
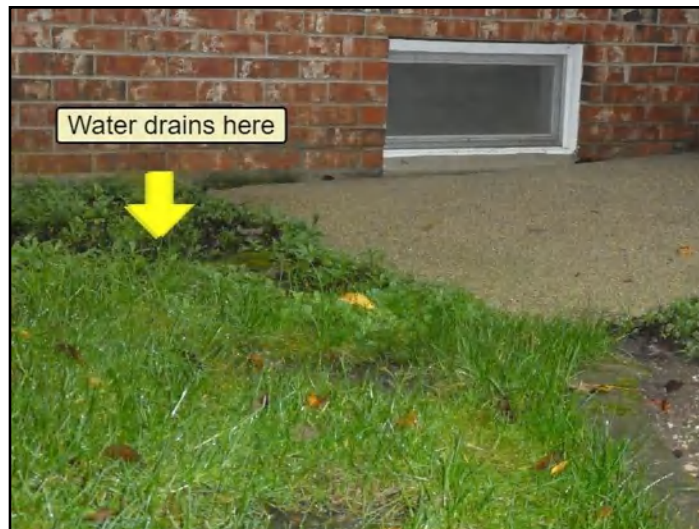
24. Condition: • Improper slope or drainage

The concrete patio in the back slopes towards the foundation as well as the steps and walk that comes from the garage. This will need to be mud-jacked or removed and replaced.

Implication(s): Chance of water damage to structure, finishes and contents

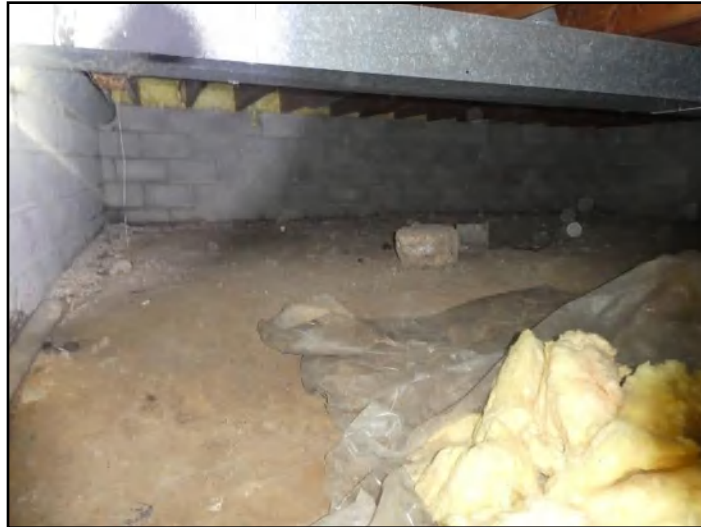
136. Dirt floor in crawl space

29. Condition: • Dirt floor in crawl space

The dirt floor will need to be corrected due to the high radon levels in basement.

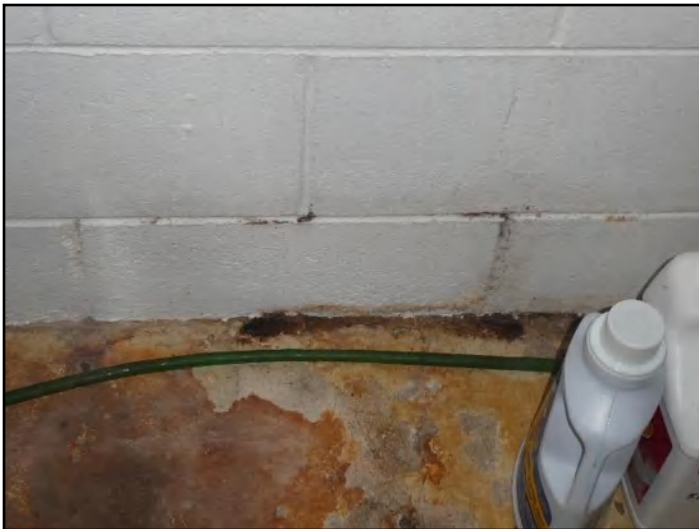
137. moisture on foundation wall

30. Condition: • Visible water on foundation wall.

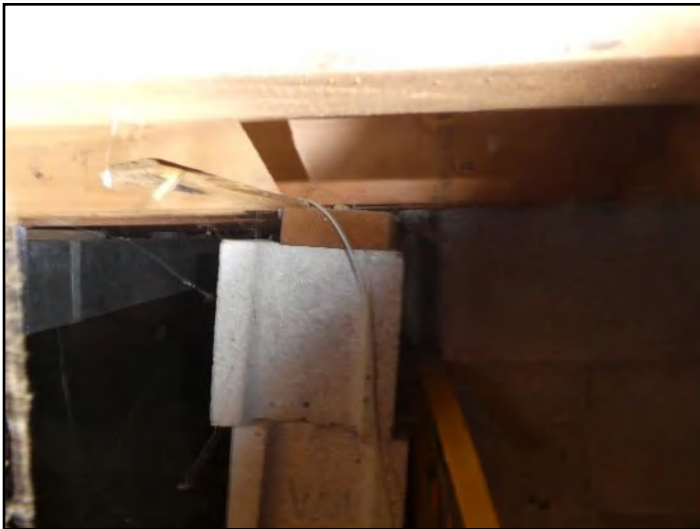
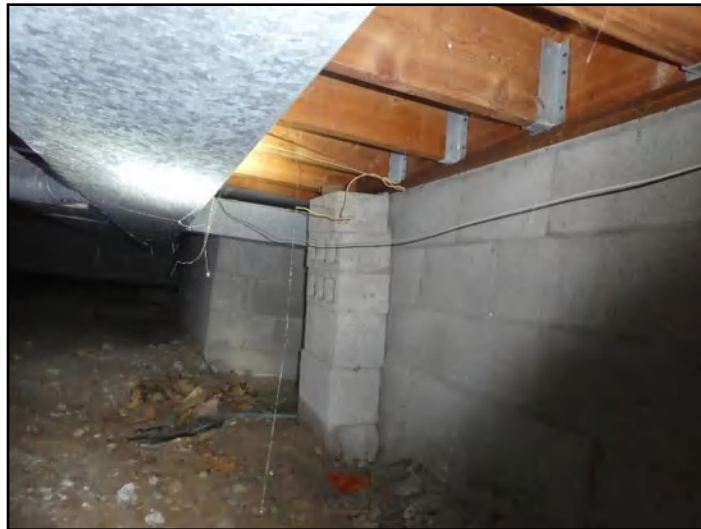
32. Condition: • Improper support

Task: Defect-improper repair

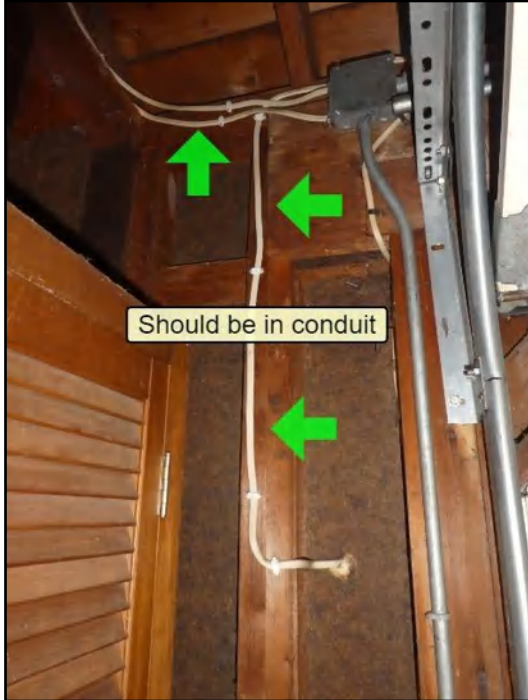
142. Unprofessional work. Consult licensed...

34. Condition: • Unprofessional work. Consult licensed electrician to correct issues.

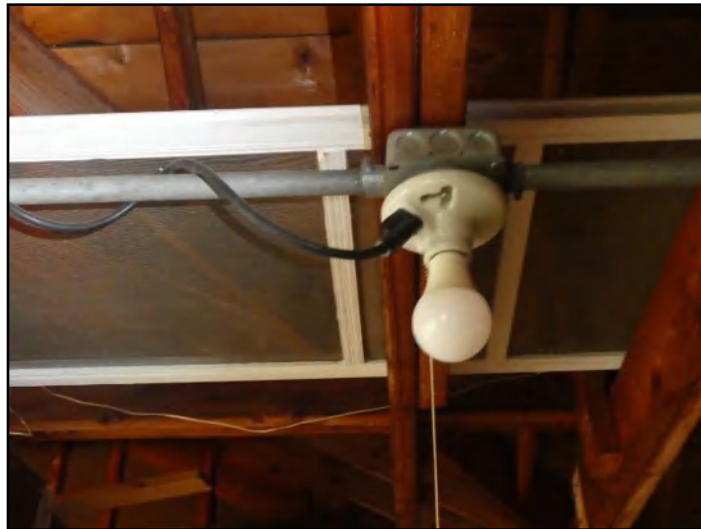
144. Open needs own outlet

35. Condition: • Garage door opens needs dedicated outlet

Task: Defect - Safety Issue

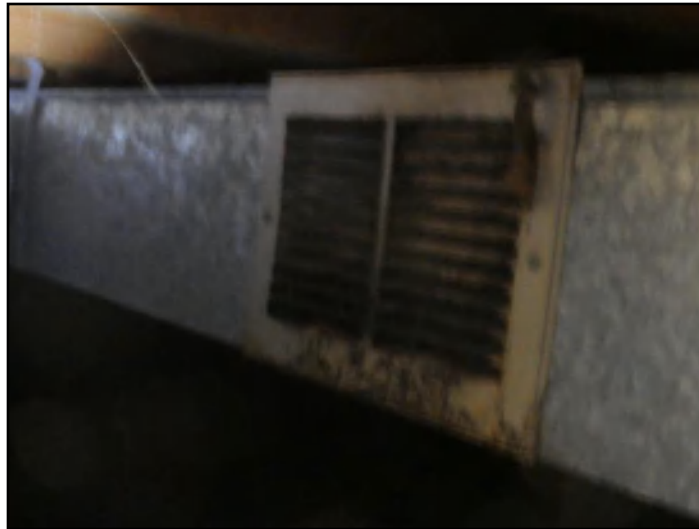
148. *Dirty vent*

36. Condition: • [Dirty](#)

Implication(s): Increased heating and cooling costs | Reduced comfort

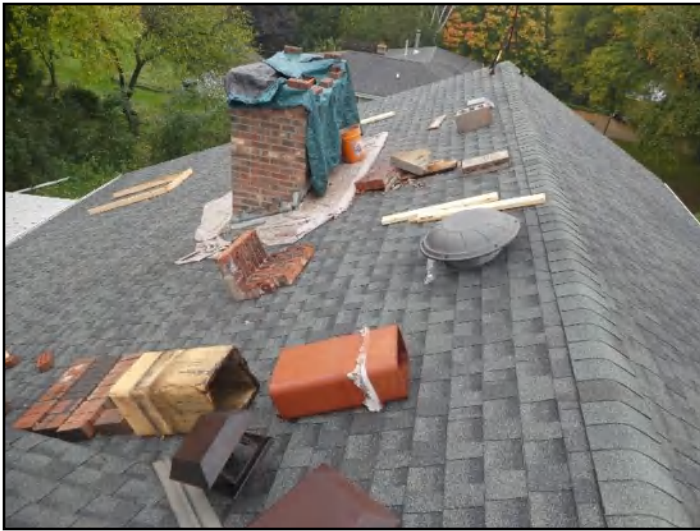
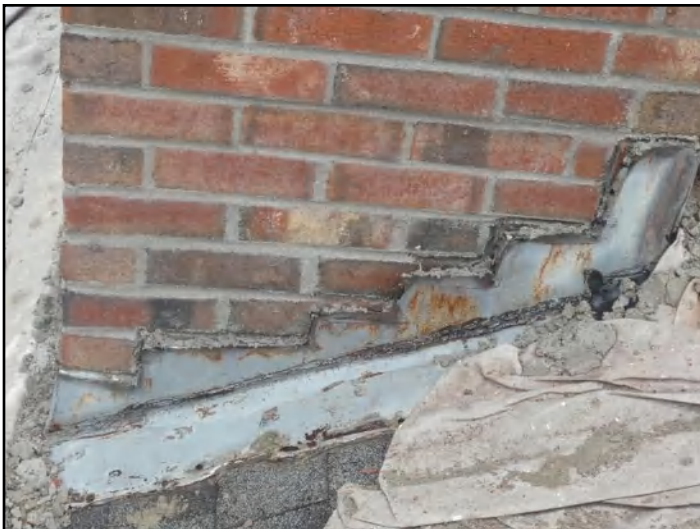
39. Condition: • Being rebuilt. The visible flue needs attention. Also the clay liner below the new one is cracked and should be replaced. A flue liner is also needed for the water heater and will need to be installed.

Task: Defect - improper repair

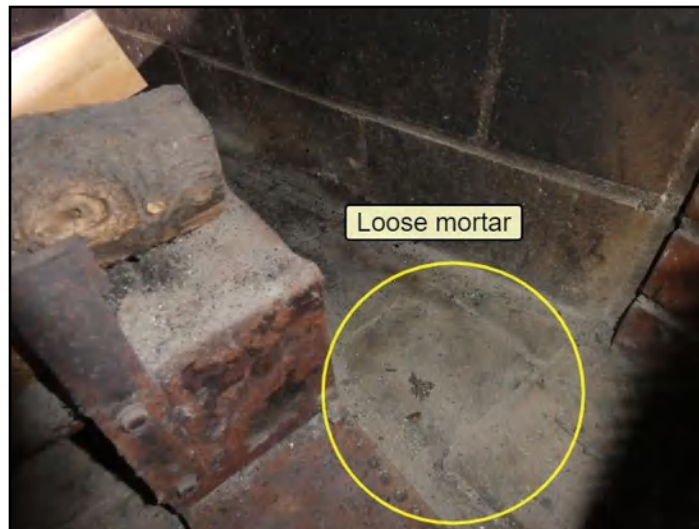
154. Deteriorated, missing or loose masonry or...

40. Condition: • [Deteriorated, missing or loose masonry or mortar](#)

Implication(s): Hazardous combustion products entering home | Fire hazard

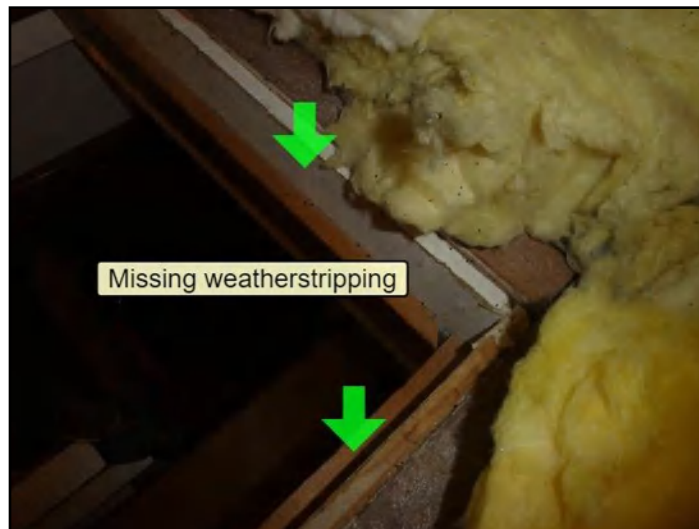
163. Not weatherstripped

41. Condition: • [Not weatherstripped](#)

Implication(s): Chance of condensation damage to finishes and/or structure | Increased heating and cooling costs

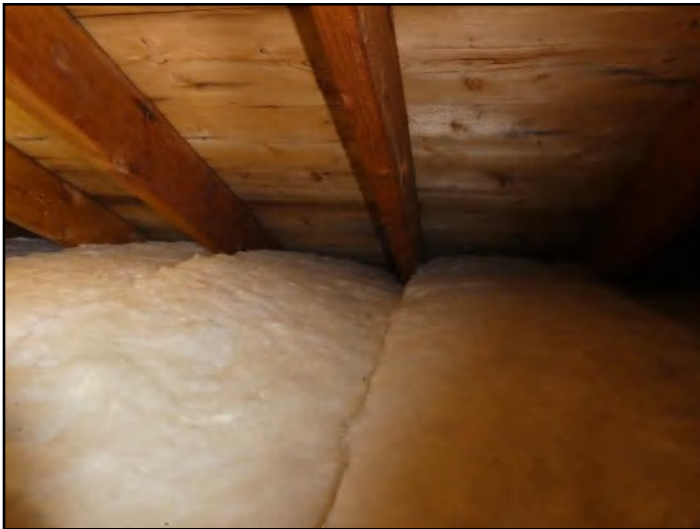
164. Missing baffles

42. Condition: • Missing baffles

The attic is not properly breathing. Not enough intake air in to the attic. Installed baffles at the soffit vents.

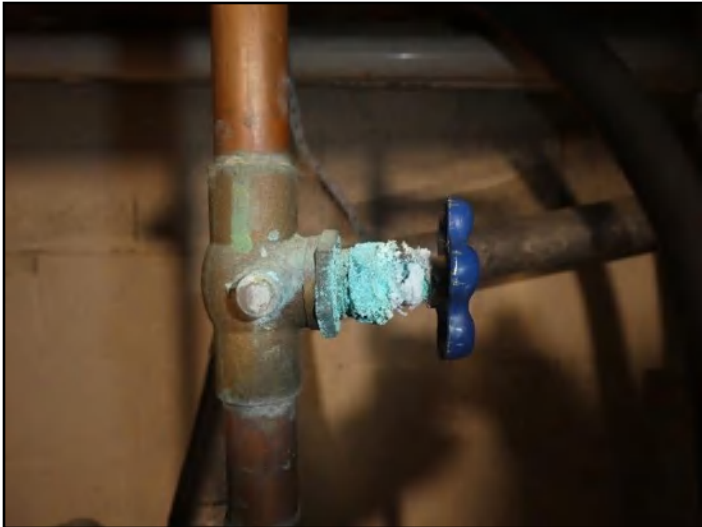
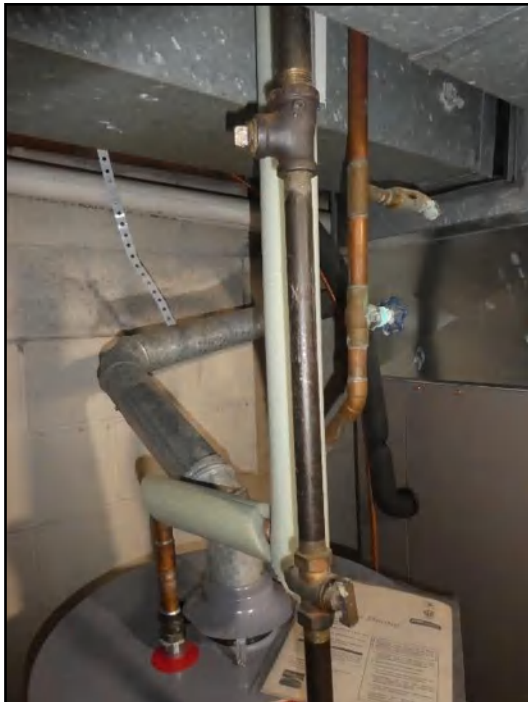
44. Condition: • Corrosion at valve. Leaking and should be replaced.

168. Leaking valve

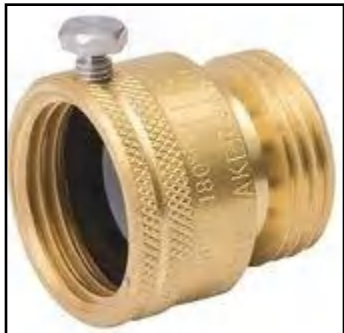
48. Condition: • Missing back flow preventor

178. Missing back flow preventor

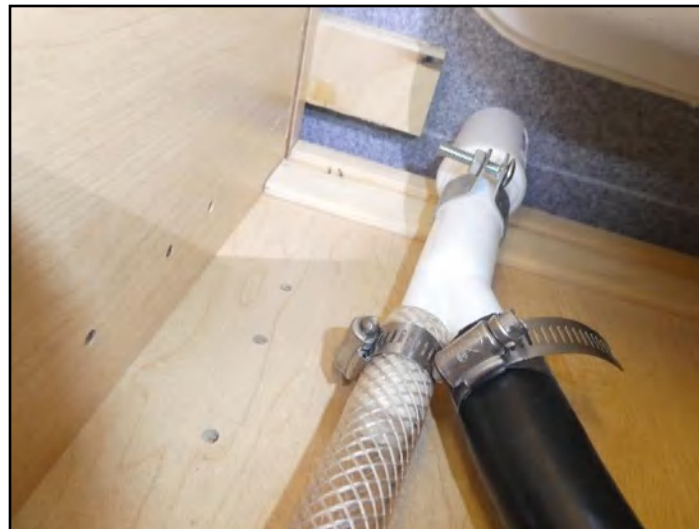
51. Condition: • Air gap issues

The air gap for the dish washer is not properly installed. Correct by licensed plumber.

Task: Defect - Safety Issue

189. Air gap issues

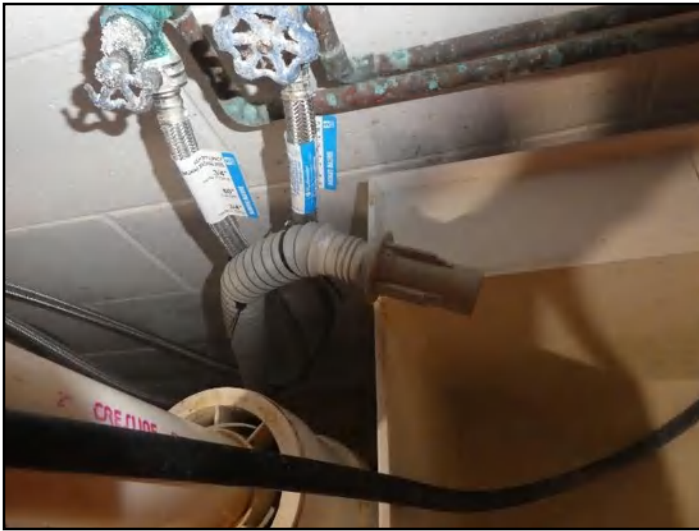
52. Condition: • Missing stand pipe

Laundry tub upgrade required a wash machine stand pipe be installed. This is missing and washer should not discharge in tub.

190. Missing stand pipe

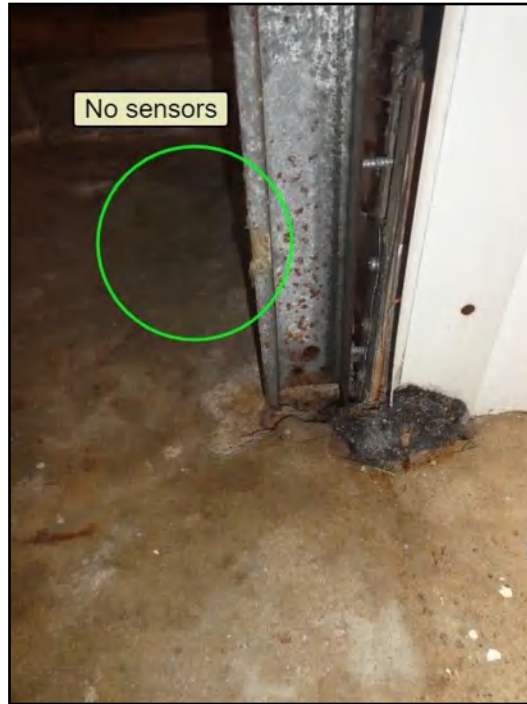
Garage door opener:

- No laser beams

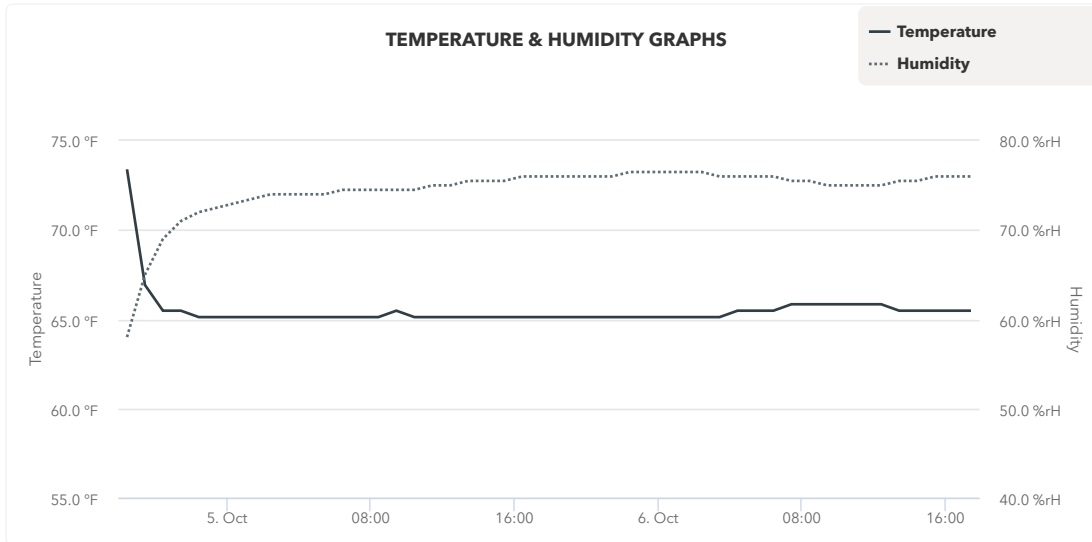
HOURLY MEASUREMENT DATA 📄

Note : Measurements are offset by 1 hour from the start of the test. (The first hour will read 3:00 for a 2:00 start time).

DATE & TIME	RADON	AIR PRESSURE	TEMPERATURE	HUMIDITY
1	2023-07-01, 6:25 p.m.	10.3 pCi/L	29.2896 inHg	73.4 °F	58.0 %rH
2	2023-07-01, 7:25 p.m.	22.4 pCi/L	29.3085 inHg	66.9 °F	65.0 %rH
3	2023-07-01, 8:25 p.m.	13.9 pCi/L	29.3215 inHg	65.5 °F	69.0 %rH
4	2023-07-01, 9:25 p.m.	17.9 pCi/L	29.3333 inHg	65.5 °F	71.0 %rH
5	2023-07-01, 10:25 p.m.	19.6 pCi/L	29.3404 inHg	65.1 °F	72.0 %rH
6	2023-07-01, 11:25 p.m.	18.4 pCi/L	29.3475 inHg	65.1 °F	72.5 %rH
7	2023-07-02, 12:25 a.m.	17.0 pCi/L	29.3534 inHg	65.1 °F	73.0 %rH
8	2023-07-02, 1:25 a.m.	15.0 pCi/L	29.3635 inHg	65.1 °F	73.5 %rH
9	2023-07-02, 2:25 a.m.	13.4 pCi/L	29.3782 inHg	65.1 °F	74.0 %rH
10	2023-07-02, 3:25 a.m.	13.7 pCi/L	29.3865 inHg	65.1 °F	74.0 %rH
11	2023-07-02, 4:25 a.m.	11.0 pCi/L	29.3924 inHg	65.1 °F	74.0 %rH
12	2023-07-02, 5:25 a.m.	16.1 pCi/L	29.4054 inHg	65.1 °F	74.0 %rH
13	2023-07-02, 6:25 a.m.	15.4 pCi/L	29.4184 inHg	65.1 °F	74.5 %rH
14	2023-07-02, 7:25 a.m.	15.1 pCi/L	29.4367 inHg	65.1 °F	74.5 %rH

The average measured radon level is at or above the Environmental Protection Agency (EPA) Action Level of 4.0 pCi/L. The EPA recommends having a radon mitigation system installed to reduce the concentration of indoor radon. Retest the building at least 24 hours but within 30 days after the system has been installed and running. The EPA recommends having the building retested at least once every 2 years to ensure the system remains effective. Performing follow-up tests during the heating season is recommended since this is when radon levels tend to be the highest. A 12-month long test, or continuous monitoring, will most accurately reflect radon exposure throughout the year.
